Location Number: NY 079

Location: Lippincott Lead Mine  
Coordinates: 37°12' / 117°08' T8S R43E S23  
Elevation: 4150'  
Map Sources: USGS Bonnie Claire NE 1:24,000; Erickson County Map  
References: Myrick; URS/Blume Files; Site Investigation 6/20/77  
Photographs: KR64-CK#9: 28-36; KR64-CK#10: 2-6; PlusX-JMC#1: 13-21  
Status: Potential National Register Site

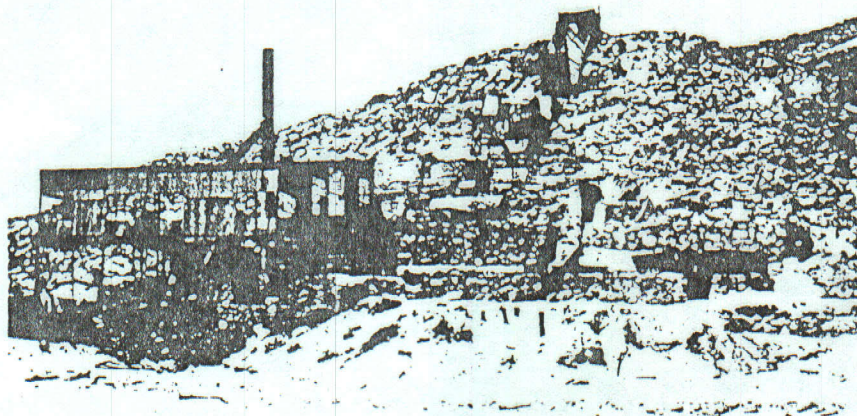
The mill complex consists of mill and residential structures. Most of the mill structures are built on the slope of the hill on stone leveling pads, some of which are unmortared. Some are supported vertically with metal and have stone and wood cross members. Near the bottom of the slope,

concrete foundations support the mill structure. Three stone residential buildings are built at the lower end of the slope. A tailing pile, also at the base of the slope, covers an area about 300' x 75'. Tailings and rocks have been piled to a height of more than 6 feet along the eastern border of the complex. The hillside is littered with rocks; metal tanks are scattered about the site; there are many lead pigs lying at the base of the mill.

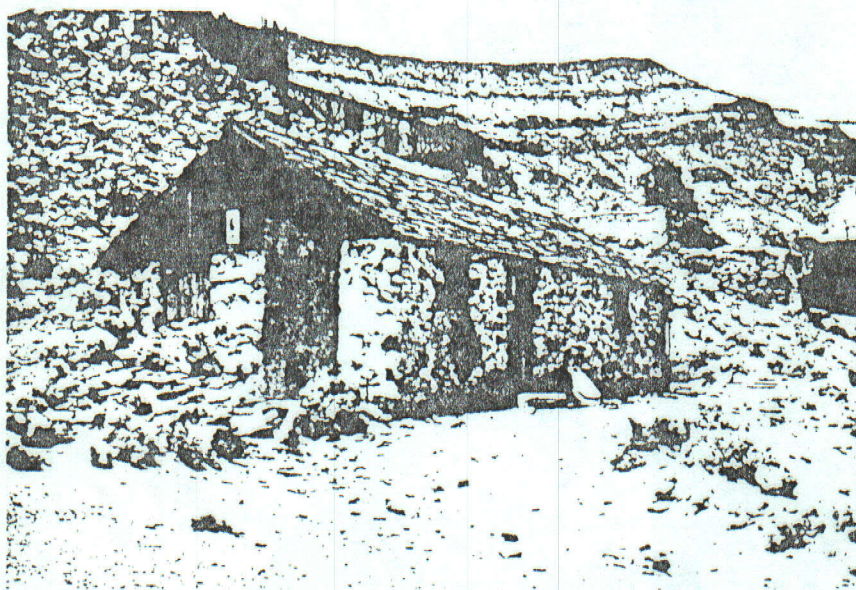
The roofed residence is of mortared angular rhyolite and is in deteriorated to fair condition. It was painted, but much of the paint has chipped off. The 12-inch-thick walls are 6 feet 2 inches high and have mortared joints. Some attempt was

made to smooth the interior surfaces with mortar; the mortar shows some cracking. The flooring is 1" x 6" timbers on 2" x 6" joists. The medium-pitched roof has 2" x 4" framing; about half of the shingles at its west end are missing. There is an 8-inch stovepipe at the northwest corner. Fenestration in the north and south elevations is 30%; in the east, 20%; in the west, 15%. The door frames are 2" x 8" timbers; the window frames, 2" x 6". Door and window jambs are notched to receive the lintels.
