0100 0014

Location Number: LN 016

Location: Kelly Mine  
Coordinates: 37°08' / 115°46' T10S R55E  
Elevation: 4860'  
Map Sources: USGS Papoose Lake Quadrangle; Erickson County Map  
References: URS/Blume Files; Site Investigation 9/3/77  
Photographs: KR64-GWK#1: 4-12  
Status: Potential National Register Site

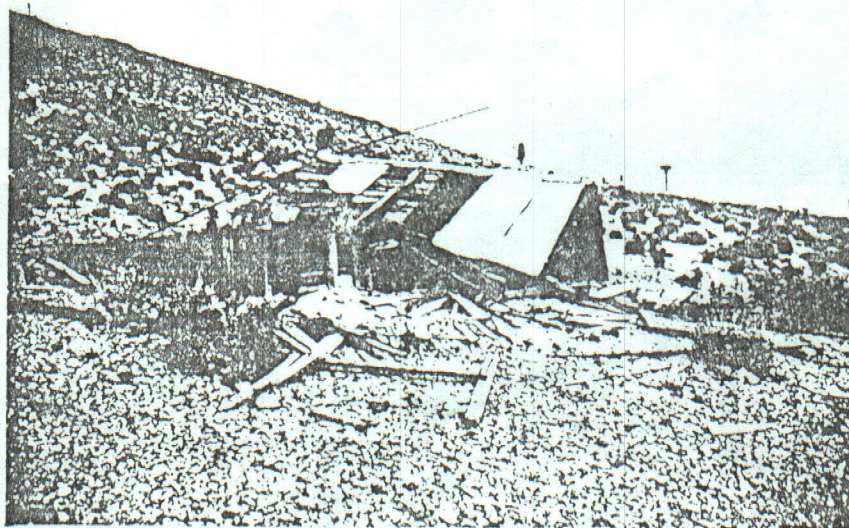
The concrete basin rests on a terrace below the tailing pile. It is approximately 6 feet square and 2-1/2 feet deep. Its walls are about 6 inches thick. Above the basin, the railroad track is supported by 4" x 6" vertical and cross members.
