PITEAU ASSOCIATES

Our file: 87-975C

November 6, 1991

Re: Geotechnical Review of Aurora Pit

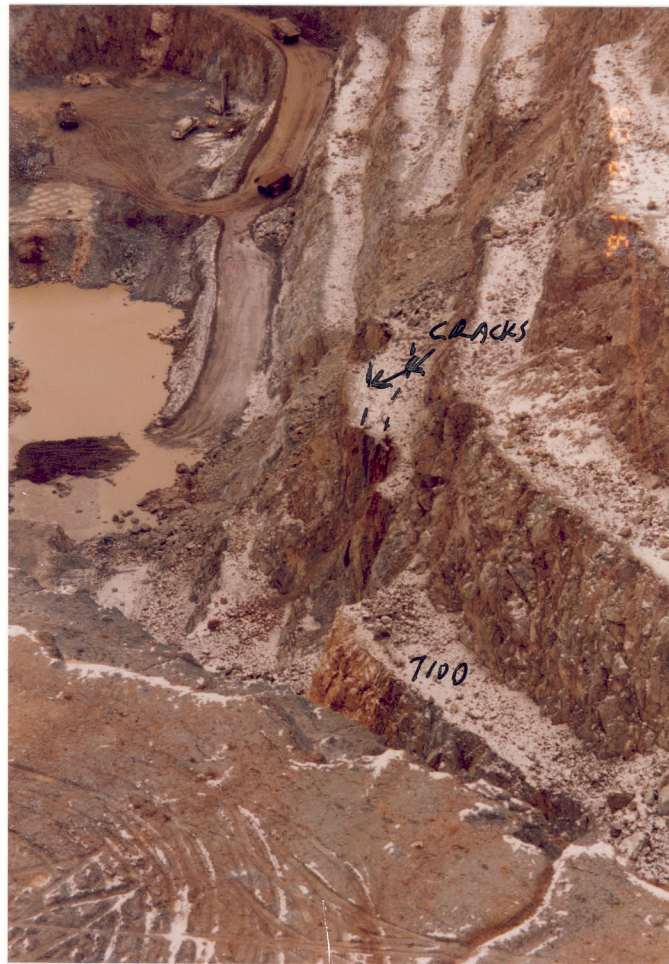
This failure is located between the 7100 and 7020 ft elevations in the vicinity of 14125N and 9500E, just east of the north wall failure discussed in our report of May 17, 1991 (see Photo 1). The failure appears to be an extension of the May 1991 failure. That is, the rock that is failing is part of or immediately in front of a major fault zone that strikes approximately N80E and dips near vertical, intersecting the south wall at a slightly oblique angle. The extent of the failure along the wall is about 125 ft. At the time of the site visit, a few rockfalls and general ravelling were occurring from the area. Cracks were observed on the 7100 safety berm within about 6 ft of the toe of the berm. One monitoring prism had been installed near the western end of the failure on the 7100 ft safety berm. Monitoring results indicated that for about the last month, the average movement rate of this portion of the slope has been 16mm/day (as opposed to prism movement rates of about 1mm/day). The results also indicated that this movement has tended to occur in a series of short spurts of greater magnitude, followed by relatively stable periods of little or no movement. These spurts of movement are thought to be related to blasting in the pit and possibly to weather (i.e. such as periods of heavy rainfall).

Based on the above, it is concluded that the failure area is unstable and could either continue to slowly break up or could fail as a relatively large mass. Furthermore, prism monitoring indicates that movement of the failure has increased in the last month and that blasting in the pit is probably related to the recent increased movement. Thus, given that it does not appear possible to remove the failure mass safely with the existing mining equipment, and it is considered unsafe to extend the ramp past this area, it is recommended that the area beneath the failure be bermed off and that the mining scenario described above that would allow ramping to a 6900 ft elevation pit bottom be implemented. Notwithstanding

PHOTO 1. West failure on south wall. Note cracks on 7100 berm.

this recommendation, it is felt that there is a strong likelihood that the failure mass will collapse on its own, and thus will be able to be removed/stabilized before mining is completed, possibly allowing the original mine plan to be accomplished (i.e. to reach the 6860 ft elevation) in the present mining phase. While it is not recommended at the present time, it may be possible to lower surface charges into the cracks at the back of the failure to try to accelerate failure of the mass. This should only be attempted if conditions are such that it can be carried out safely, and there is a high probability of success without causing further damage to the wall.

To better assess the state of stability of this area, it is recommended that a second prism be established on the 7100 safety berm towards the east end of the failure. This should only be done once safe access to this area of the 7100 berm has been re-established (i.e. after the east failure discussed below has been stabilized). Prisms should be monitored and results assessed at least every second day. Visual inspection of the failure area should be carried out on a daily basis and personnel should not be allowed in the pit bottom in the vicinity of the failure.

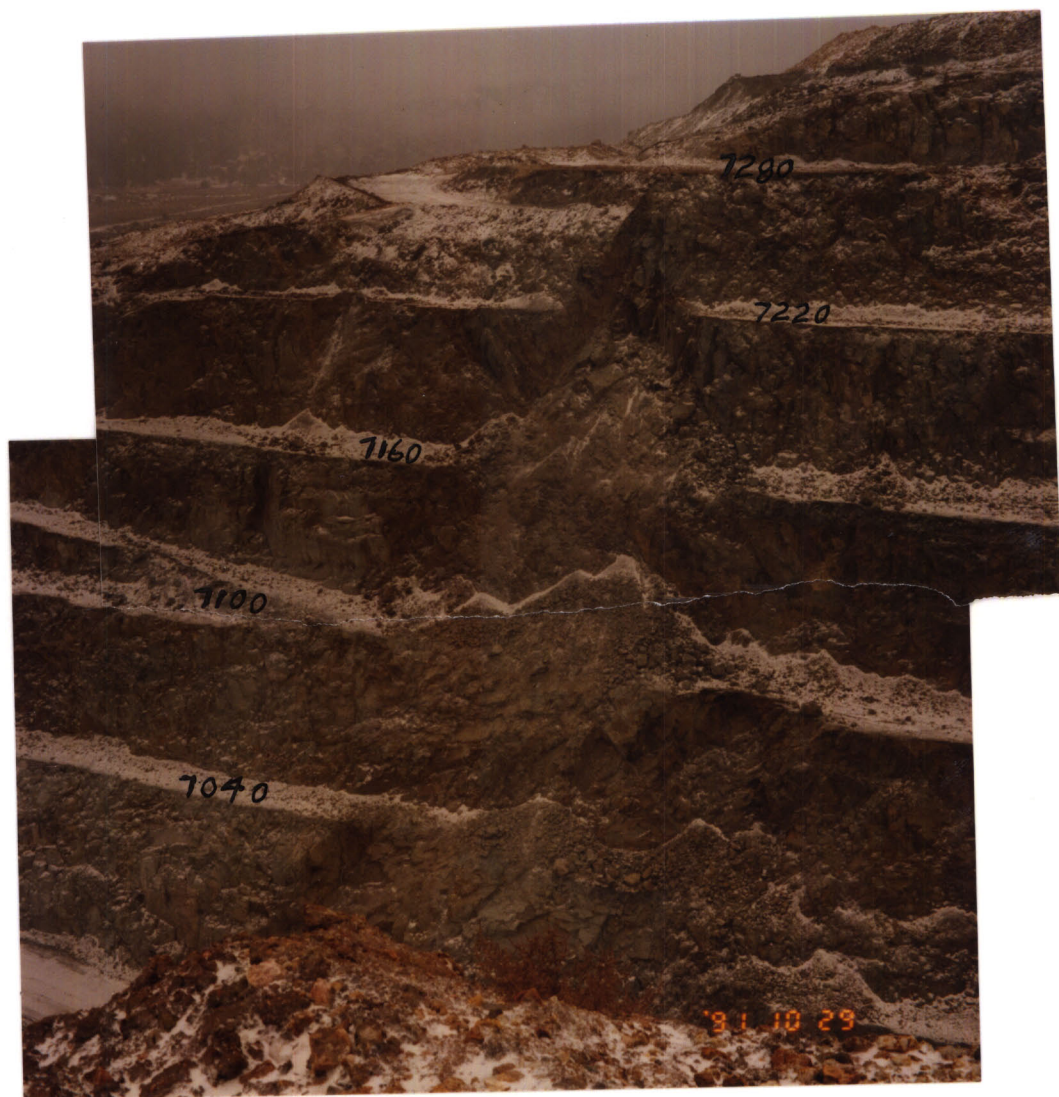
This failure area is located just east of the west failure (see Photo 2). It appears to involve primarily bench scale planar sliding on joints of Joint Set E, with lateral release/sliding on joints of Joint Sets B and D (see PAEL reports of February and November 1988 for description of joint sets). While joints of Joint Set E are observed in other areas of the south wall, they are usually relatively discontinuous and only result in breakback of bench crests. However, in this area, the joints are more frequent and more continuous, with a few being as long as about 50 ft.

At the time of the site visit, the failure had broken back to the pit crest at the 7280 ft elevation, with some cracking appearing near the toe of the 7280 berm. Most of the berm width below the crest in this area had either been filled with rubble or had been lost due to breakback of the individual bench crests. Rockfall and raveling activity was occurring sporadically from above the 7160 ft elevation.

While the above described failure represents an immediate hazard to men and equipment operating underneath it, in that any rockfalls are likely to reach the pit bottom, it is concluded that the slope should be able to be stabilized to an acceptable level. In this regard, and as there is ready access to the top of the slope, it is recommended that an initial 20 ft high cut be taken from the crest of the slope between the 7280 and 7260 ft elevations. This will remove a significant amount of unstable fractured

PHOTO 2. East failure on south wall.

and loosened rock from the crest area. The slope should then be inspected and, if necessary, a second, and possibly a third, 20 ft high cut of rock should be removed. At each step, any loose material should be scaled from the slope with the backhoe (which can reach about 20 ft below the level on which it is working). Once this is completed, the slope should be inspected to determine if there are any potential rockfalls that are still hanging up on the slope. If such potential rockfalls exist, and assuming that they can be safely accessed, it would be advisable to attempt to hand scale them from the slope. Such work should be done from the top of the slope downward, and only if the slope above where men are working has been satisfactorily scaled of all loose material. Extreme caution should be used at all times when carrying out this work.

As soon as possible following the above remedial work, at least three prisms should be established on the 7280 ft level, with at least one prism being installed behind the crack on the 7280 level. At least daily visual inspections should be carried out in this area while men and equipment are working on or below the slope. Depending on the results of such monitoring and inspection, additional scaling or the installation of additional prisms or possibly crack monitors may also be required.

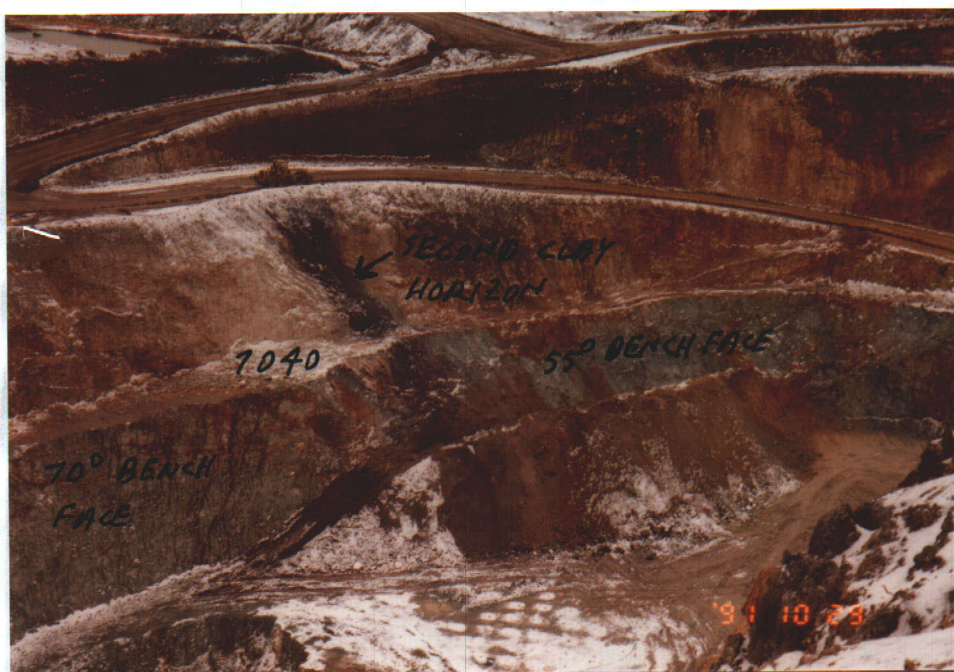
The recent failure in the clay horizon (see PAEL reports of February and November 1988 for description of clay) occurred toward the east end of the north wall below the main haulroad. In this area (see Photo 3), a second clay horizon, striking approximately normal to the wall and dipping subvertically, appears to have intersected the main clay horizon that has always been present on the north wall. The failure, which has effected a slope height of up to about 120 ft, apparently was comprised of two or three different stages, including bulging and squeezing of the clay and collapse of the overlying bedrock onto the clay horizon. Remedial measures instituted by the mine involved pushing the slope back slightly by re-establishing the safety berm at the 7040 ft elevation and excavating the bench face below the 7040 ft level at an angle of about 55°. No ore has been lost during re-establishment of the slope and the 55° bench face appears to be stable. It is noteworthy that stable benches with bench face angles of about 70° have been established in clay in other areas of the north wall. Based on discussions with mine personnel, it would appear that the clay horizon will not be present on the north wall below the present pit bottom (i.e. the 6980 ft level), and will be left on the wall.

The exact reason for the above slope failure is unclear; however, it is likely that the presence of the second clay layer, probably representing a shear zone, has had an influence on the slope behaviour. Also, the

constant heavy traffic on the haulroad immediately above the failure may have helped to initiate movement. Furthermore, it is suspected that water pressure behind the clay (i.e. possibly from natural groundwater or water from the small pond behind the slope) may have contributed to the failure.

PHOTO 3. North wall failure in clay horizon following re-establishment of the slope. Note second, near vertical clay horizon.

While the remedial resloping appears to have been effective in re-establishing the slope, it is recommended that drainholes be drilled into the slope from the haulroad and, if possible, from below the haulroad on the 7040 bench. Once the 6980 level is mined out, it would also be advisable to drill a few drainholes from this bench level. Lateral spacing of the drainholes should depend on their effectiveness. However, a nominal spacing of 50 to 100 ft and a similar depth (or to whatever depth is possible with available equipment) would likely be appropriate.

To conduct ongoing monitoring of this portion of the north wall, prisms should be installed on the slope. In this regard, it is recommended that two prisms be installed on the haulroad north of the switchback, with an additional two on the 7040 ft safety berm below. Depending on monitoring results, it may be advisable in the future to add further prisms on the 6980 safety berm. Because of the importance of the haulroad, these prisms should be monitored regularly (i.e. at least twice a week). Visual monitoring of this area should also be conducted regularly.
