July 15, 1966.

Re: Condition of and damages to
White Peaks Mercury Mine, from
recent operations.

Your White Peaks mine, under lease and option to Cinnabar Canyon Mines, Inc., since 1964, was examined On July 10 and 11, 1966, by the writer.

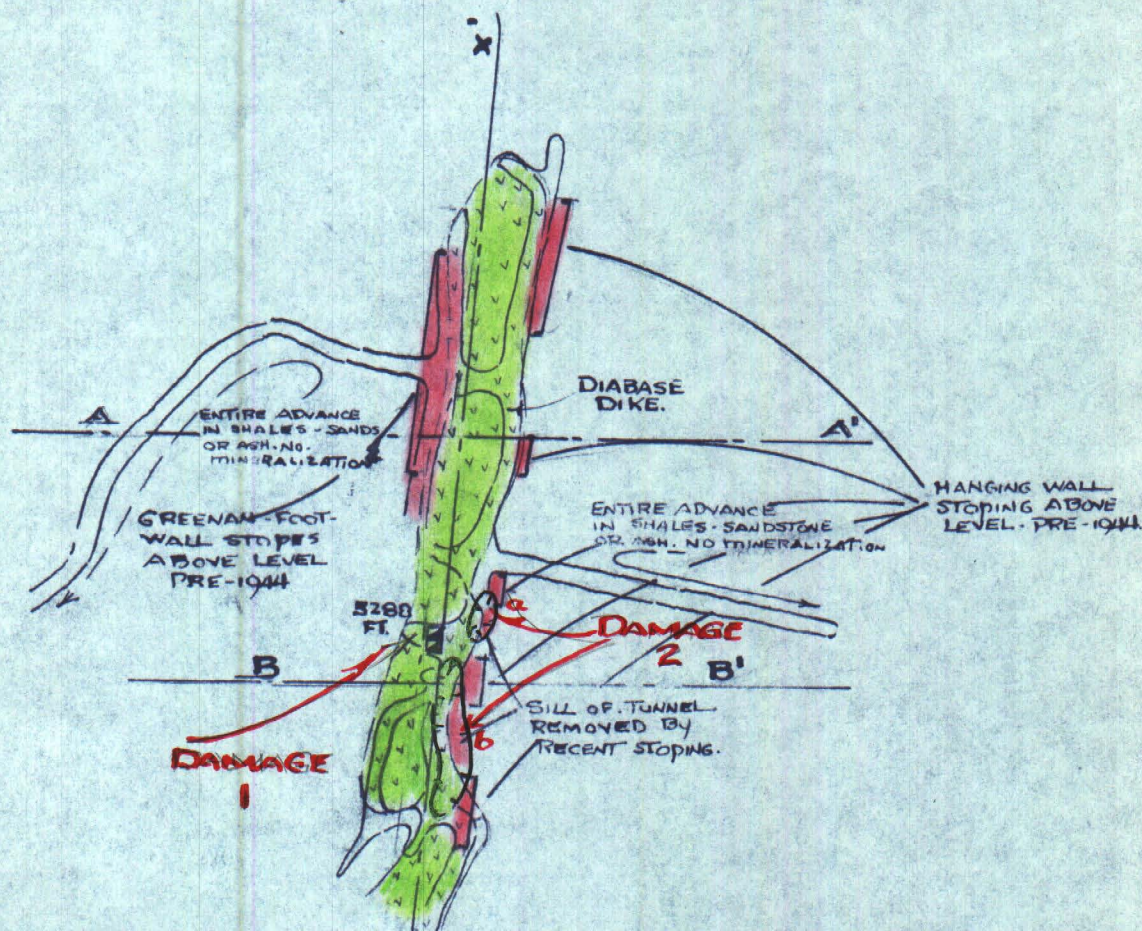
SCOSSA MINES
MERCURY
BOTTLE CREEK DISTRICT
HUMBOLDT CO., NEVADA
WHITE PEAK MINE
62 LEVEL
1" = 50 FT.

Damage #1 represents the condition of the shaft above the 62 level. The area has been weakened, should be carefully checked, lagging and timbering replaced and strengthened, and openings between lagging and the solid filled with 'gob'.

Existing open ground behind timber invites trouble if water enters the shaft, during the occasional cloud-burst periods which do occur in the area.

Damages #2, at (a) and (b) on Flat C, are the product of mining in an "un-minerlike fashion". At "b" all but about a foot of the original sill has been destroyed for a distance of about 40 feet, by robbing the underlying pillar. Access to the south face of the 62 level can only be made by (1) filling the underlying stope, (2) trestling across the open space, or (3) driving a new drift west of the damage. The mining of pillars is good mining practice only when a property has been proved to have no future possibilities. The operator in this case, by robbing the pillars and destroying the sill of the level, has seriously damaged a property with a remaining potential, especially on the 160 level and below.

At "a", only a thin remnant of the underlying pillar remains; continued passage over the pillar will destroy it, make access to the north impossible and, with its position 10 to 15 feet from the shaft, greatly weaken the only access to lower levels.

Competent miners should be put to work in the White Peaks shaft to (1) repair the shaft above the 62 level where needed, (2) bridge over the 40 feet of open ground at (b) with solid timbering and a trestle (a temporary expedient since the void should be filled) and (3) with stulls from below supporting a mat of timber and the remainder of the pillar, the pillar, itself, might be saved.

This plus the a general cleanup and timbering, with two men working for a month, should be accomplished for about \$2500.

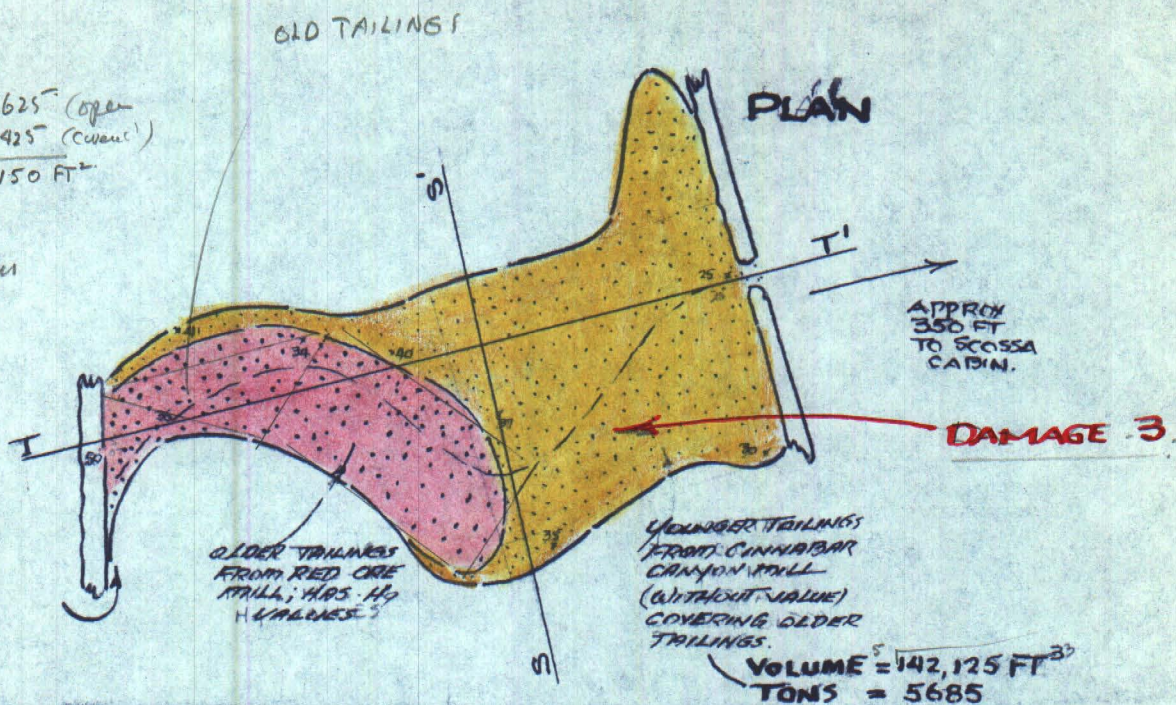
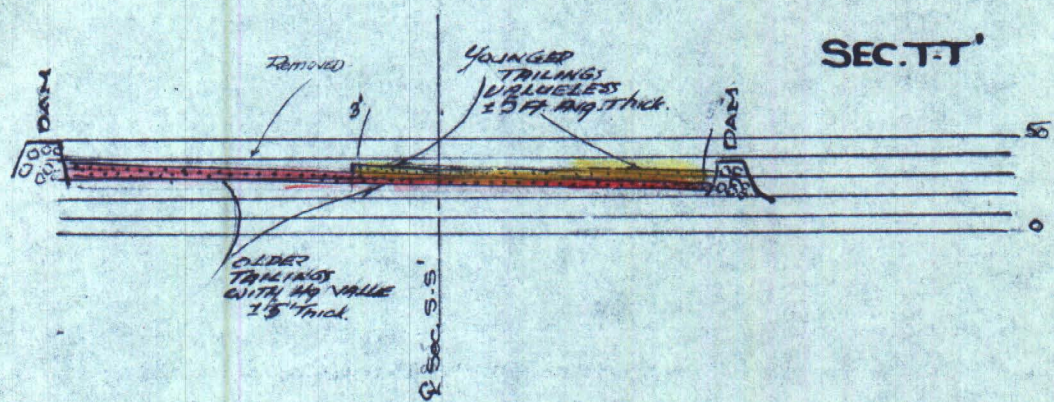
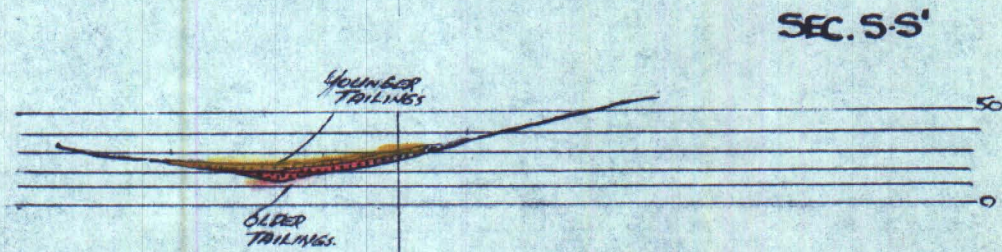
TAILINGS
WHITE PEAK NO. 3
1" = 100'

With reference to the plat, note the contrasting colors, the red representing an estimated 7 feet of thickness of cinnabar bearing sand, covered by the umber, an estimated 5 feet of recent sand-tailings with only traces of cinnabar.

The variation in cinnabar content between the two was established by panning. The older tailings, in red, have been estimated at 3 pounds of mercury per ton.

By Brunton-compass survey and an estimated thickness of seven feet, 11,000 tons of mill tailings were available for treatment from the pond. 11,000 tons remain but the operators with recent tailings have covered 8,000 tons of the total.

The blanketing of an asset with a thickness of five feet of barren material is not considered "miner-like" procedure. An asset has been destroyed, unless it is again uncovered.

The removal of 5500 to 6000 tons of loose barren sand from the tailings pond, without diluting the underlying cinnabar sand may require ingenuity. The use of a bulldozer has been suggested, but the weight of a D-7, on such a soft surface, invites only partial removal with perhaps 40% of the waste, ground into the material to be saved. It is believed that the standard scraper, tied to an anchor on the north side of the pond, with tugger hoist placed on the south side, would do the clean job desired. \$1500 is estimated as the cost of this remedial work.
