Nye County
Item 35

Location Number: NY 067

Location: Site 370
Coordinates: 37°42' / 116°53' T3S R45E
Elevation: 5720'
Map Sources: USGS Cactus Spring Quadrangle
References: U.S. Navy; Site Investigation 9/3/77
Photographs: PlusX-GWK#1: 6-7; PlusX-GWK#2: 4-17
Status: Potential National Register Site

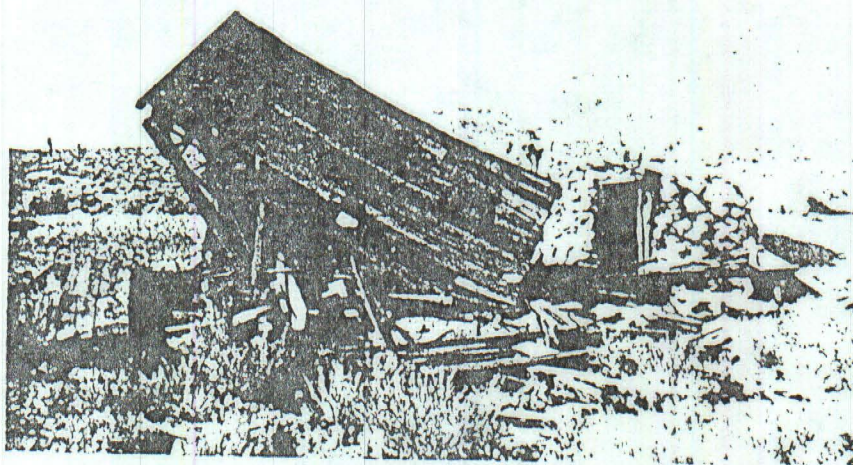
At the extreme northeast end of the site is a wood-frame structure about 22' x 20' that has almost completely collapsed. The roof, constructed with 2" x 4" rafters and a single kingpin gable, is sheathed with wood. The floor is hardwood over 2" x 4" joists. This structure is in hazardous condition.

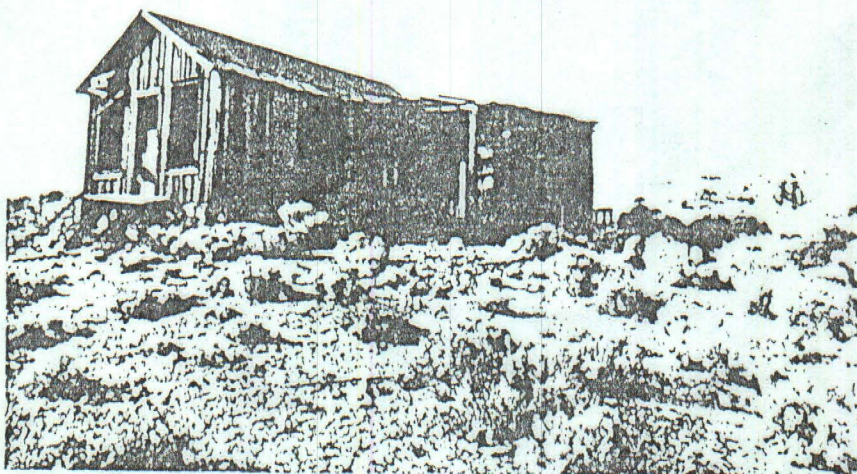
The main part of the building is about 22' x 15' and has a north-south long axis. The walls, of board-and-batten set vertically, are covered with corrugated metal in places; the north elevation contains a door and two win-

dows below the gable. On the west side is an open addition with a flat roof; the west elevation of this addition is the only one to have been completed. Another covered addition, on the south, is about 24' x 16' and was perhaps used as a workshop. Railroad ties and wooden posts are used for vertical support for its partially collapsed gabled roof. A low rubble-rock wall forms the bed for a road through a wash area at this part of the site.
