Location Number: NY 066

Location: Gold Crater
Coordinates: 37°32' / 116°53' T5S R45E
Elevation: 5520'
Map Sources: USGS Cactus Spring Quadrangle; Erickson County Map; Clason 1906
References: Carlson; Paher; Mordy; Ball; U.S. Navy; Site Investigation 9/3/77
Photographs: KR64-GWK#1: 35-36; PlusX-GWK#1: 5; PlusX-GWK#2: 1
Status: Potential National Register Site

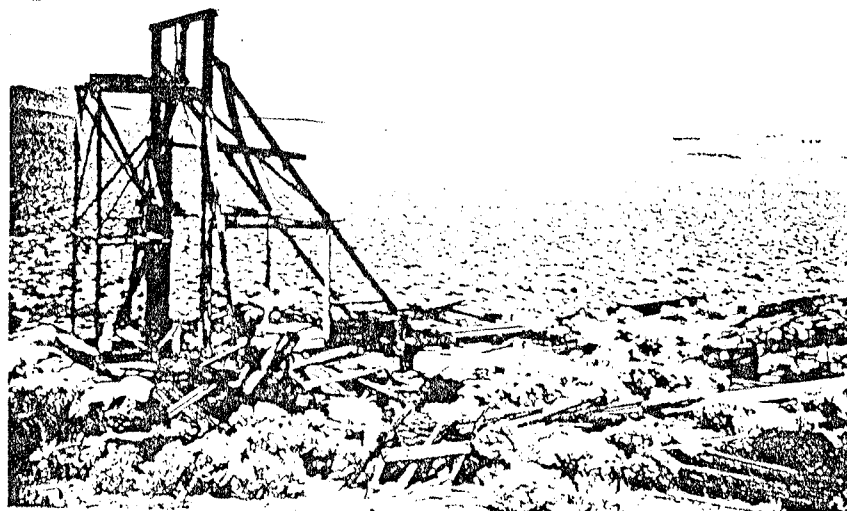
At the mine site are a 42-foot-high headframe on 4" x 12" and 4" x 6" diagonal and vertical supports; the tailing piles; and mining equipment and debris.
