(240)
Item 23

Location Number: NY 015

Location: Manhattan
Coordinates: 38°32' / 117°05' T8N R44E S19
Elevation: 6905'
Map Sources: 1:250,000 Tonopah; Toiyabe National Forest Map; Clason 1906;
Nevada Map Atlas; Erickson County Map
References: Carlson; Paher; Mordy; Angel; Elliott; Historic Markers; URS/
Blume Files; Site Investigation 7/28/77
Photographs: KR64-JMC#1: 35-36; PlusX-JW#7: 0-10
Status: Potential National Register Site

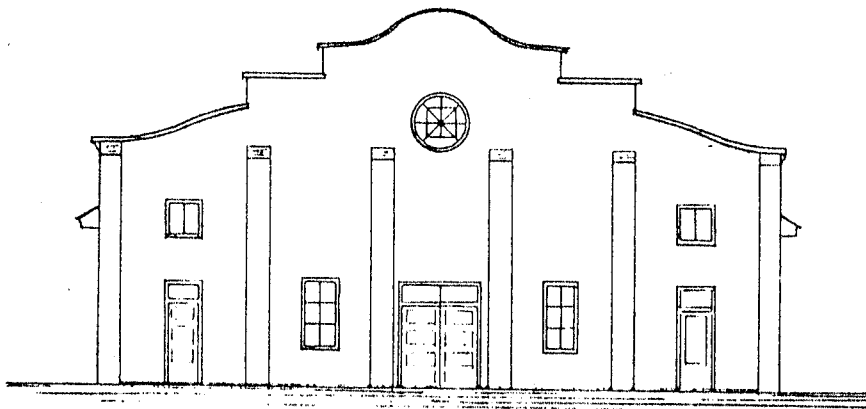
Edison Substation

are set at roof level above windows about 3' x 7' placed on grade. Fenestration is 15%. A door and three windows in the north elevation provide 20% fenestration; double doors and two windows in the south elevation provide 30%. An engaged column in the center of each of these elevations reaches to the roof. All doors and windows are framed with wood; the doors are of wood. The 30-foot ceiling is braced with steel. Both the concrete walls and their plastered interior surfaces exhibit severe cracking.

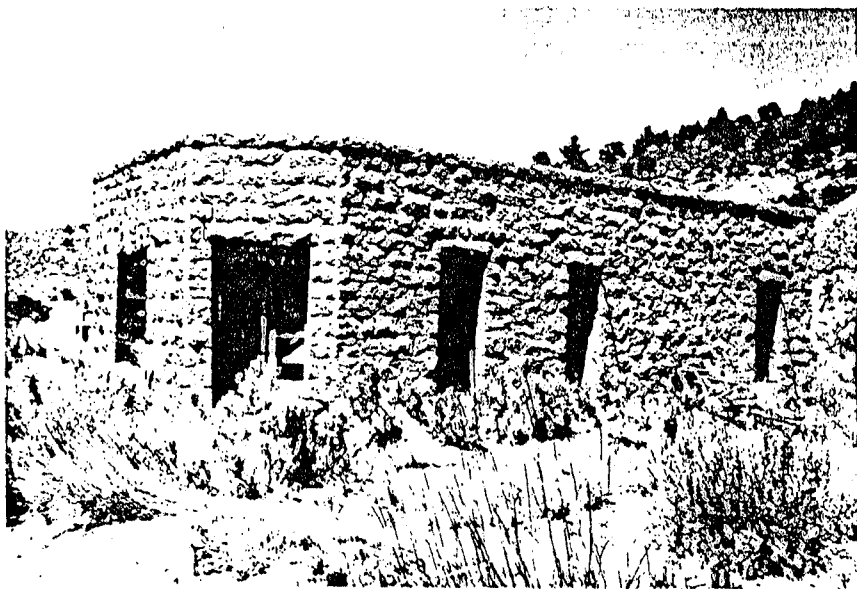
2'-6" x 7'-8", a double window 7'-8" x 7'-2", and a single window 2'-10" x 8'. The ceiling of this structure has partially collapsed; vertical cracks in the stone walls extend to the full height of the north and west elevations.
