*Nye County*  
Item 36

Location Number: NY 062

Location: Mellan  
Coordinates: 37°43' / 116°35' T2S R48E S34  
Elevation: 5520'  
Map Sources: USGS Mellan Quadrangle; Erickson County Map; Nevada Map Atlas  
References: Paher; Sandia; U.S. Navy; Personal Communication with Cecil Lang; Site Investigation 6/23/77  
Photographs: KR64-CK#12: 3-5; PlusX-JMC#5: 16-20  
Status: Potential National Register Site

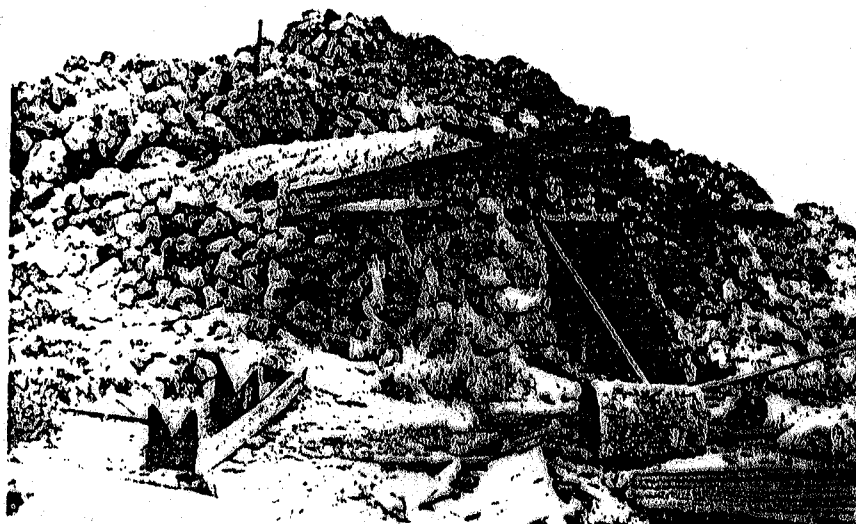
The dugout is 24' x 18' and 7 feet high, with the long axis trending north-south, and is in excellent condition. The construction is angular rock of various sizes

with mud chinking.

The floor is dirt;

the roof is of

peeled logs and

sod over corru-

gated metal. The

ridgepole is a 4-

inch metal pipe

that supports 2-

rafters.

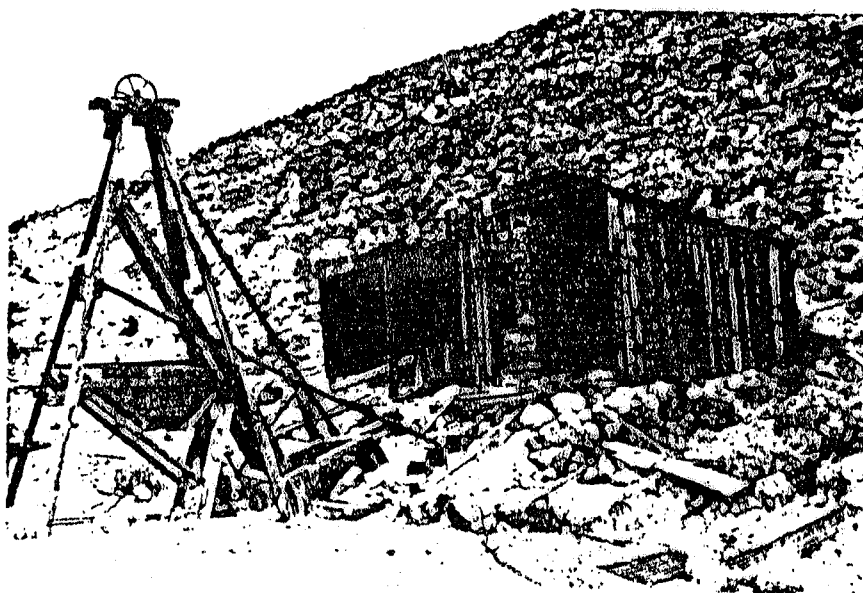
Farther up the hill is a mine hoist and a badly deteriorated wood-frame building. The 12-foot-high hoist is constructed of 2" x 12" timbers. It

has no diagonal bracing, but the horizontal members are adequate. The 30' x 12' building is 8 feet high and was used as an equipment building.
