## 3180 0007

Location Number: NY 034

Morey

Potential National Register Site

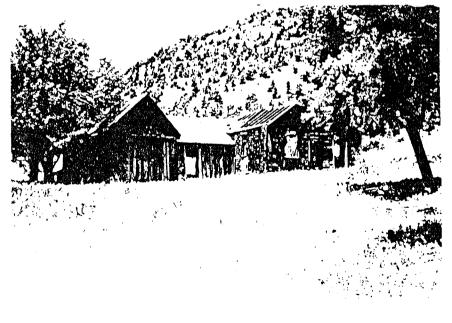
Among the structures at the site is a stone dugout cellar 15' x 15' x 8 feet deep. The roof is peeled logs topped with bark and then sod and dirt. The dugout is about half underground. An 8-foot-high adobe wall stands as the front elevation of the cellar, and this

wall has been used as the back wall of a contemporary structure, thus a connecting house and cellar.

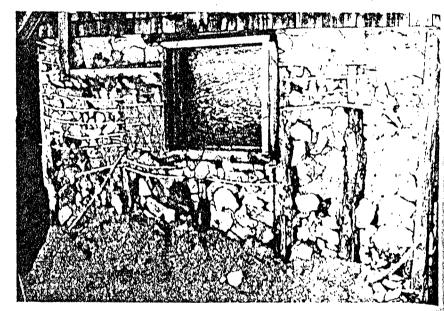
The south wing of this structure is  $28' \times 12' \times 14$  feet high. It is partitioned into two rooms with a small addition on the south elevation. This wing is constructed of 3" to 4" hand-hewn studs and horizontal sticks with rock

filler and daubing.
The roof is a highpeaked eave with an
east-west long axis.
The roofing is shingles covered with tar
paper. There is no
flooring as the lumber has been removed.

The north wing is partitioned into three rooms and is constructed partly of

mud-mortared rock (the north elevation) and wattle-and-daub and lath-and-daub. One room has 1"  $\times$  10" flooring, the others none. The dimensions are 24'  $\times$  22'  $\times$  14 feet high. The medium-rise roof is covered with 1"  $\times$  10" sheathing.

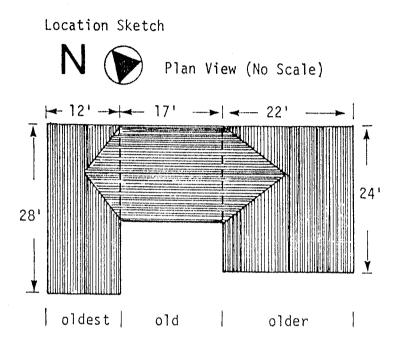
The structure is in generally poor condition. The wattle-and-daub crumbles to the touch and the north elevation is partially collapsed. The foundation is unmortared rock that has fallen in places. The chimney has eroded at the roofline and there are many loose bricks.
