## 4420 0006

Location Number: NY 052

Silverbow

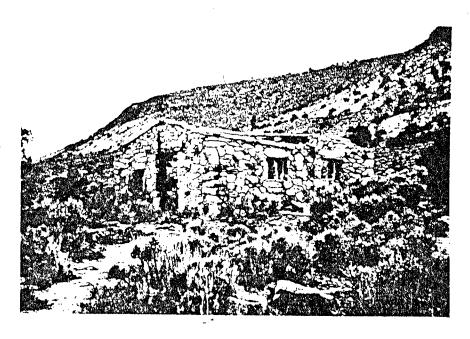
The principal rock structure has no roof. It is a one-room house  $20'-5" \times 15" \times 9$  feet high and is in fair condition. It is built of angular rock of vary-

ing sizes and is mud chinked on the interior and exterior walls. The long axis of the low-pitched gabled structure is eastwest. Its walls are 2 feet thick. The north and south elevations rise 7 feet to a peeled-log ridge-pole, which supports

log rafters. These rafters are held in place by notches cut into the rock walls. The west elevation has no openings; the north and south elevations have 10% and 15% openings, respectively; the east elevation holds a door and two windows and has 25% fenestration. The door and windows are framed with milled 1" x 6" lumber. The doorway has two hand-hewn 8" x 8" log lintels, which extend 18 inches into the walls on either side of the door. These lintels are shimmed into place with wooden wedges. Each window lintel is one shaped rock that spans the opening. It extends into either side of the wall about 6 inches. The floor of this structure is dirt, which is part of the 2:1 slope that the structure is keyed into.
