PROPERTY NAME: Redrock claims

County: Elko

Mining District: Tuscarora

EXAMINER: Bentz/Smith

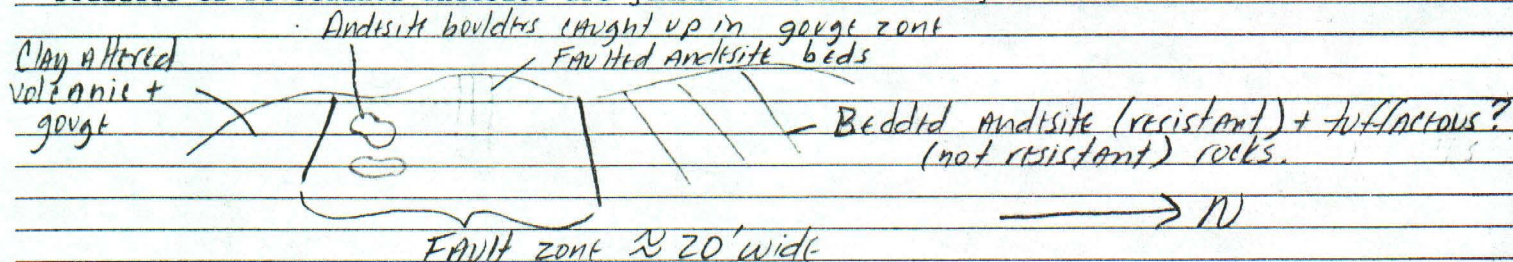
GEOLOGY: Main trench trends N30E & exposes a highly oxidized shear zone in andesite. The
andesite is crystal rich & contains hornblende, biotite & plagioclase phenocrysts. A
suggestion of bedding in the outcrop indicates these rocks may be flows but their
holocrystalline texture appears intrusive. The fault zone is generally E-W
striking. The rocks within the zone are sheared, fractured & locally altered to clay &
limonite. Steep limonite-stained fractures & fissures occur throughout the zone. Large
boulders of Fe-stained andesite are jumbled within the clay altered zones.

Schematic view of shear zone in trench. View looking West.
