**MINEREX RESOURCES LTD.**

**AURORA PROJECT**

**GEOTECHNICAL ASSESSMENTS AND PRELIMINARY  
DESIGN CONSIDERATIONS RELATING TO  
OPEN PIT SLOPES AND EXCAVATION METHODS**

**FEBRUARY 1988**

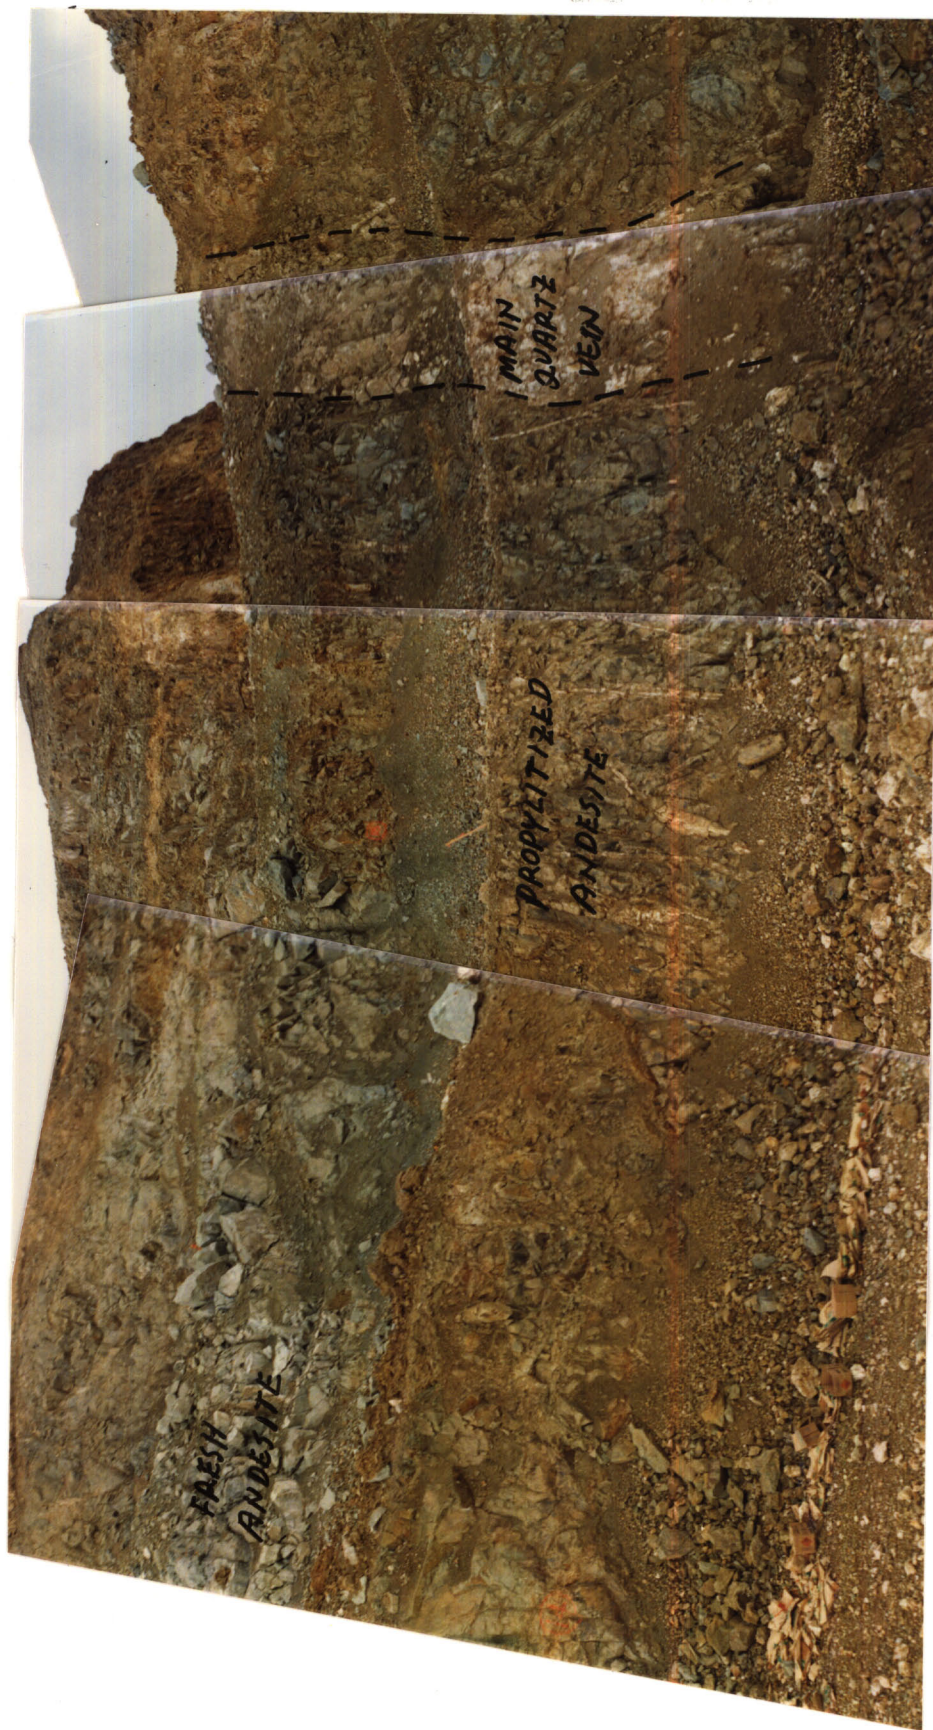
PHOTO 1. Looking at fresh and propylitized andesite on footwall of main quartz vein from 7180 bench.

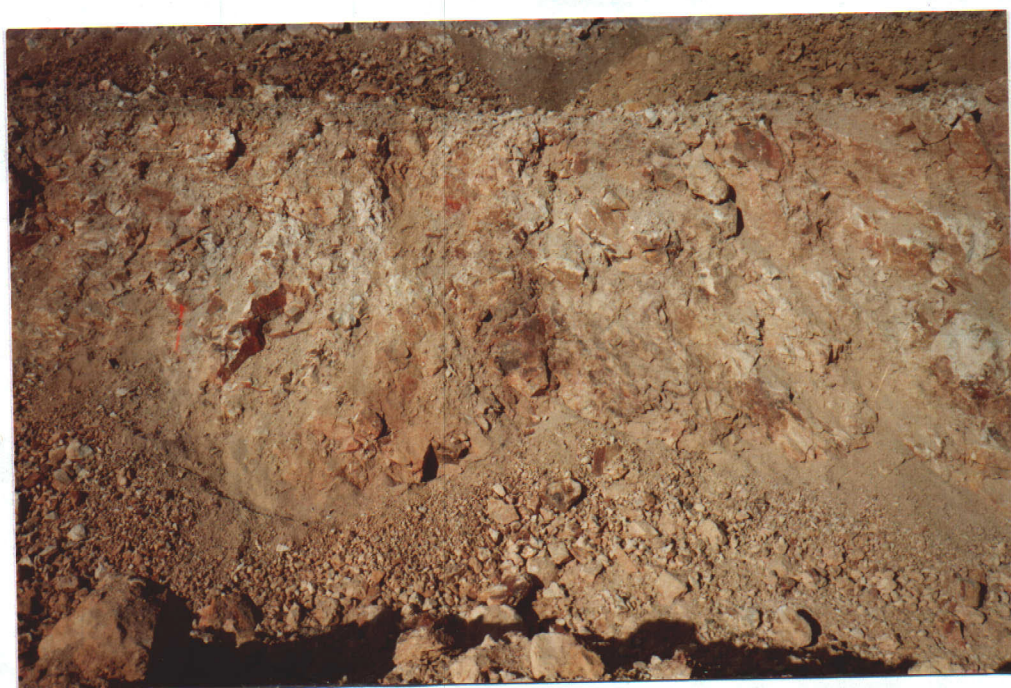
PHOTO 3. Lightly altered rhyolite on the 7180 foot bench.

Rhyolite, which overlies the altered andesite (see Photo 3), will likely be exposed in the upper portion of the northwestern wall of the open pit. Along the contact with the moderately to heavily altered andesite, which appears to be a fault contact in some locations, the rhyolite is typically moderately to heavily altered, with the degree of alteration diminishing with distance from

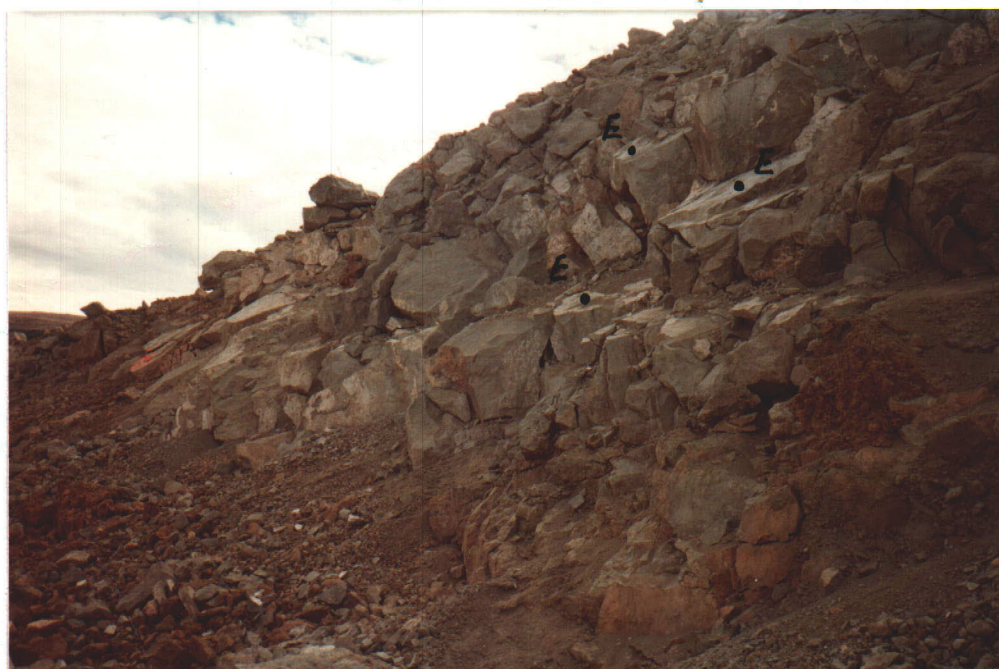
PHOTO 4. Overblasted fresh andesite. Note joints of Joint Set E.

Joints of Joint Set E strike approximately east-west and dip moderately to the north. These joints have an adverse orientation for the southeast pit wall that will be excavated in relatively fresh andesite on the foot-wall side of the main quartz vein. It is noteworthy that their presence was most noticeable in the recently excavated benches within the andesite, where the rock had been overblasted and significant breakback of the bench crests had occurred (see Photo 4). In the areas of the pit that have been mined by previous operators, little evidence of these structures is present and very little breakback on these structures has occurred. Based on this, and observations of the joint surfaces, it is felt that the potential adverse effects of this joint set can be minimized by careful excavation techniques.
