(214)
Item 12

Location Number: NY 073

Location: Merger Mine
Coordinates: 38°02' / 116°25' T2N R50E
Elevation: 7260'
Map Sources: USGS Warm Springs Quadrangle
References: Site Investigation 7/14/77
Photographs: KR64-CK#15: 19-21; PlusX-JMC#8: 25-31
Status: Potential National Register Site

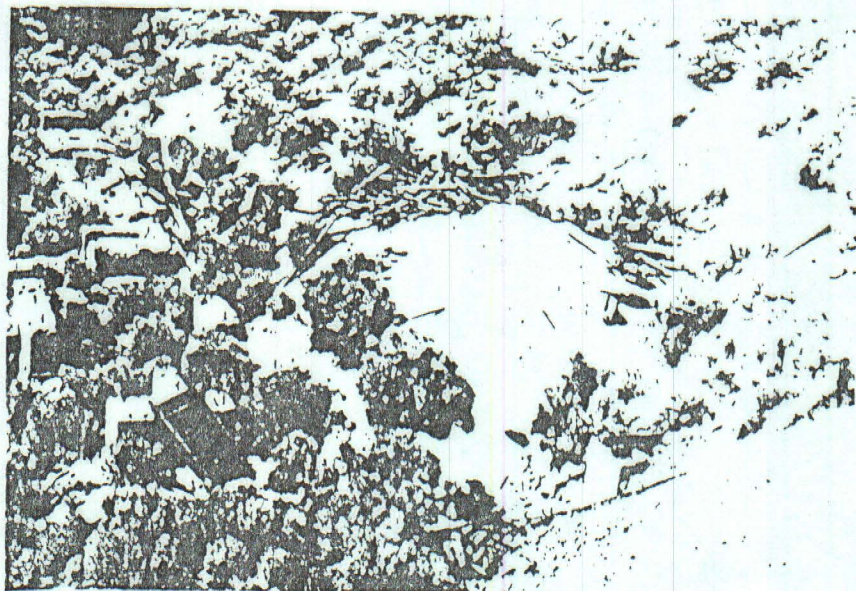
The site is marked by a large tailing pile, leveled in places by walls of unmortared angular rubble rock. On the hillside next to one end of the tailing

pile are the remains of an old mill, apparently a large structure to judge from the large quantities of highly weathered timber lying about. The complex was built at four levels. The second level from the top has heavy concrete foundations and probably

held the mill's machinery.
