## HAER INVENTORY

Historic American Engineering Record  
Department of the Interior, Washington, D.C.

Comstock State Historic District

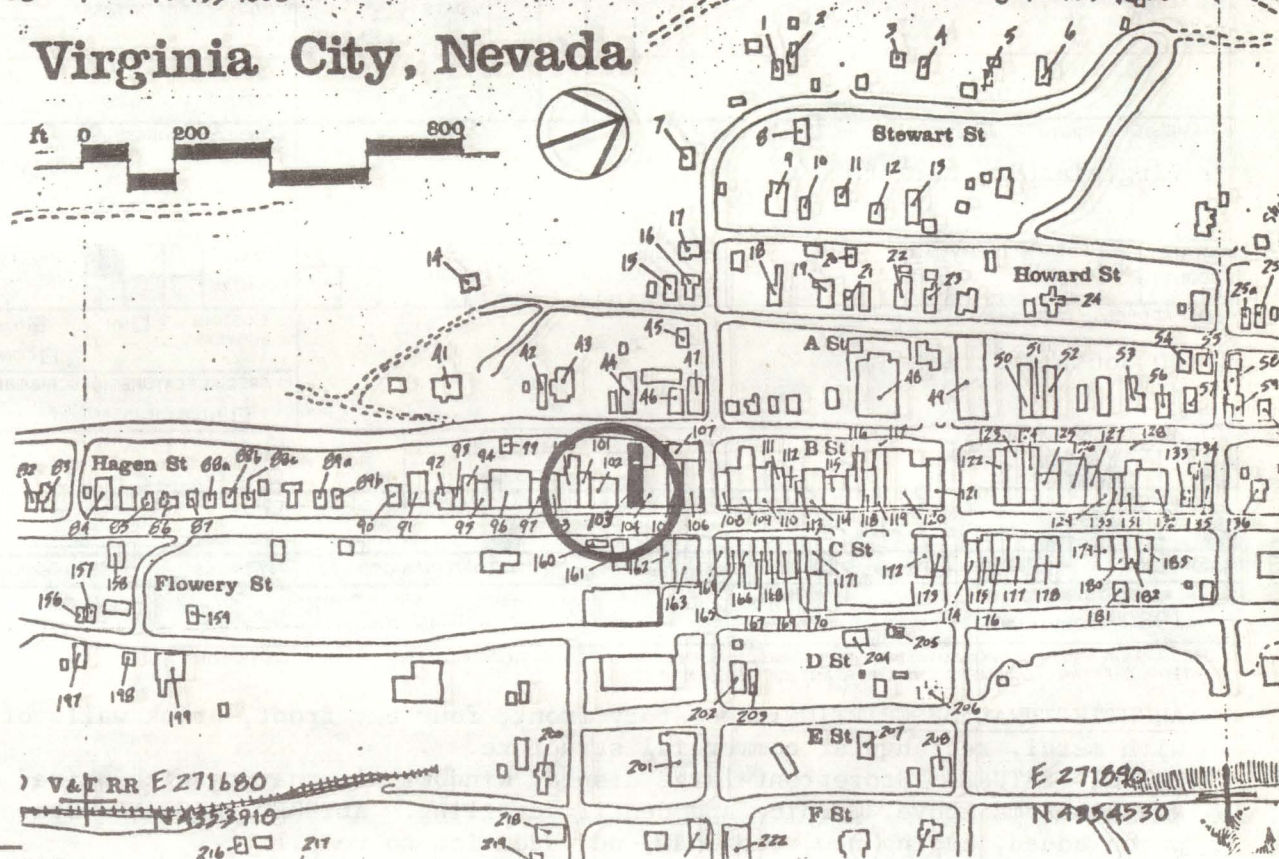
INTACT FEATURES: Storefront-large display windows alternating with paired doors, has cast fe pilasters, and transoms above. Cornice and dentil detailing. ALTERED /MISSING Storefront transoms covered with paint, porch added, caping new, roof new, new addition to rear.

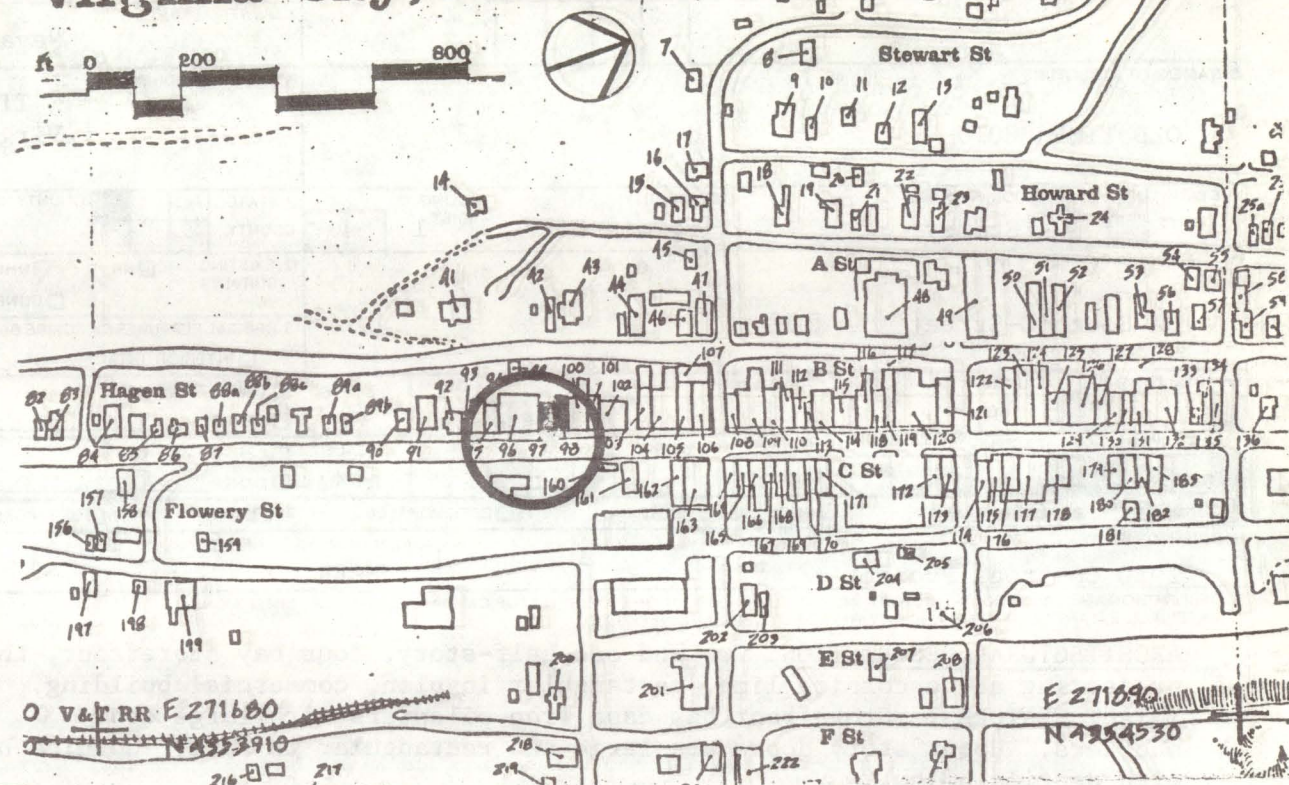
ALTERED MISSING: Upper story doors are framed as to resemble windows. Porch missing, cornice detail is deteriorating. Upper portion of cornice is missing.

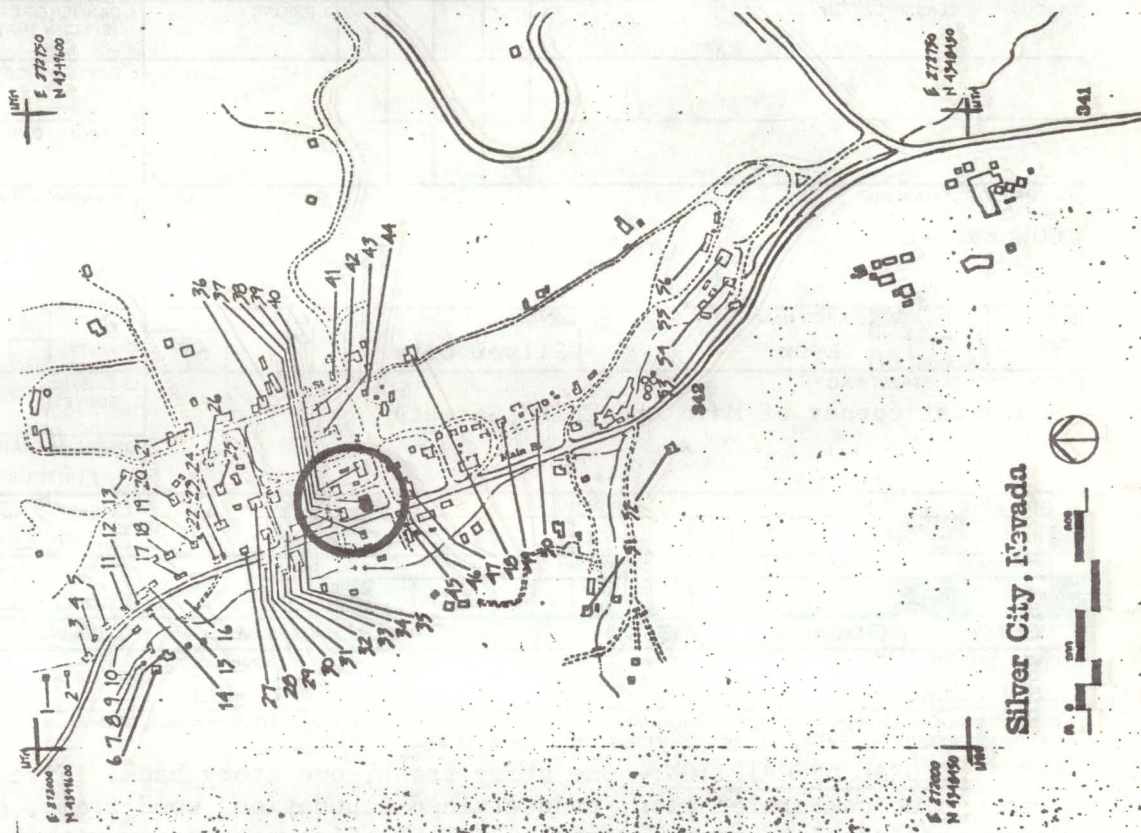
**ARCHITECTURAL DESCRIPTION:** One story front, one story back. Five bays front, 2 bays side, 5 bays back. Rectangular commercial plan, undetermined foundation, wood frame, shiplap siding. Gable, and partial flat roof. Corrugated steel roofing material. **INTACT:** Sidewalk canopy with balustrade. Straight cornice on flat roof segment of building. Glass panel doors. Sash windows (various). **ALTERED:** One story addition to rear.

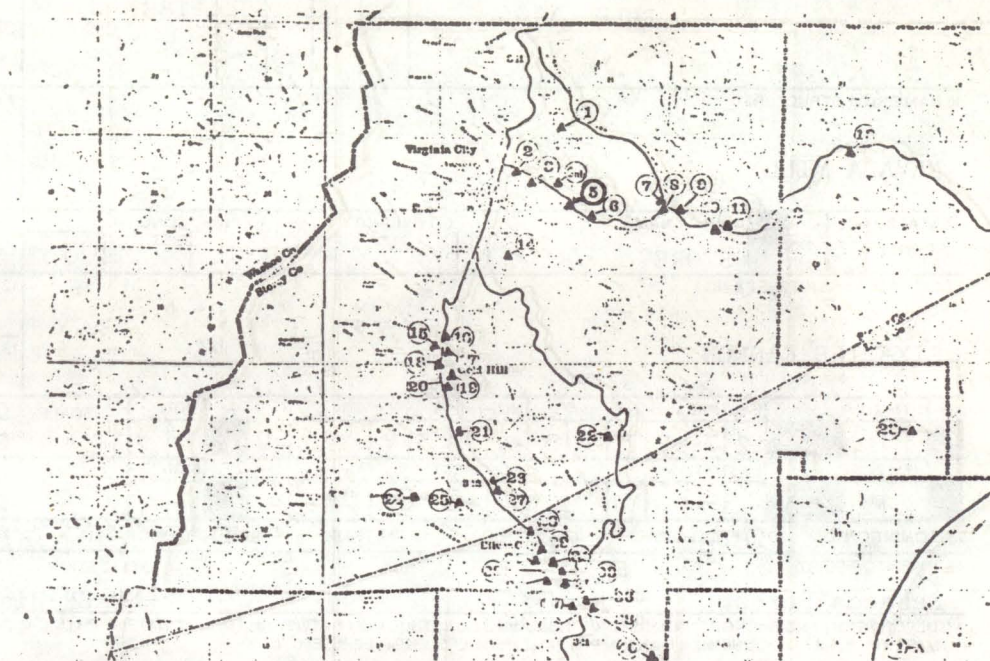
# 25. PHOTOS AND SKETCH MAP OF LOCATION

DESCRIPTION (CONTINUED) Brush dynamos, which generated approximately 65% of the power used in the mill. The interior of the mill was lit by electricity, as well as the grounds which were illuminated by means of an arc lamp suspended on a tall mast. In 1900, the electric power used to operate the mill was brought from the power plant on the Truckee River, 40 miles away. This mill was the first to use electricity as well as the last to use the Washoe pan process.

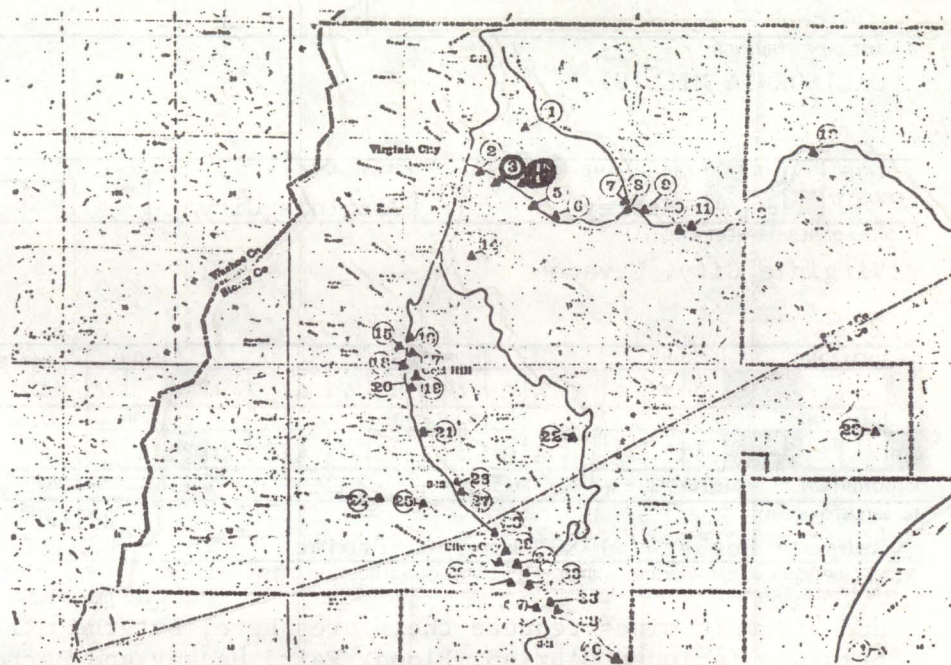
# 25. PHOTOS AND SKETCH MAP OF LOCATION

DESCRIPTION (CONTINUED) Pelton was caught and conducted to the C&C shaft, where it was used on a series of wheels of the same size and by means of steel wire cables, used as belts, the power of all of the lower wheels brought to the main driving shaft on the surface. It was then transmiited to the pan mill by means of steel wire cables passing over pulleys placed on a series of tall wooden towers. The California stamp mill was in operation as late as 1887.

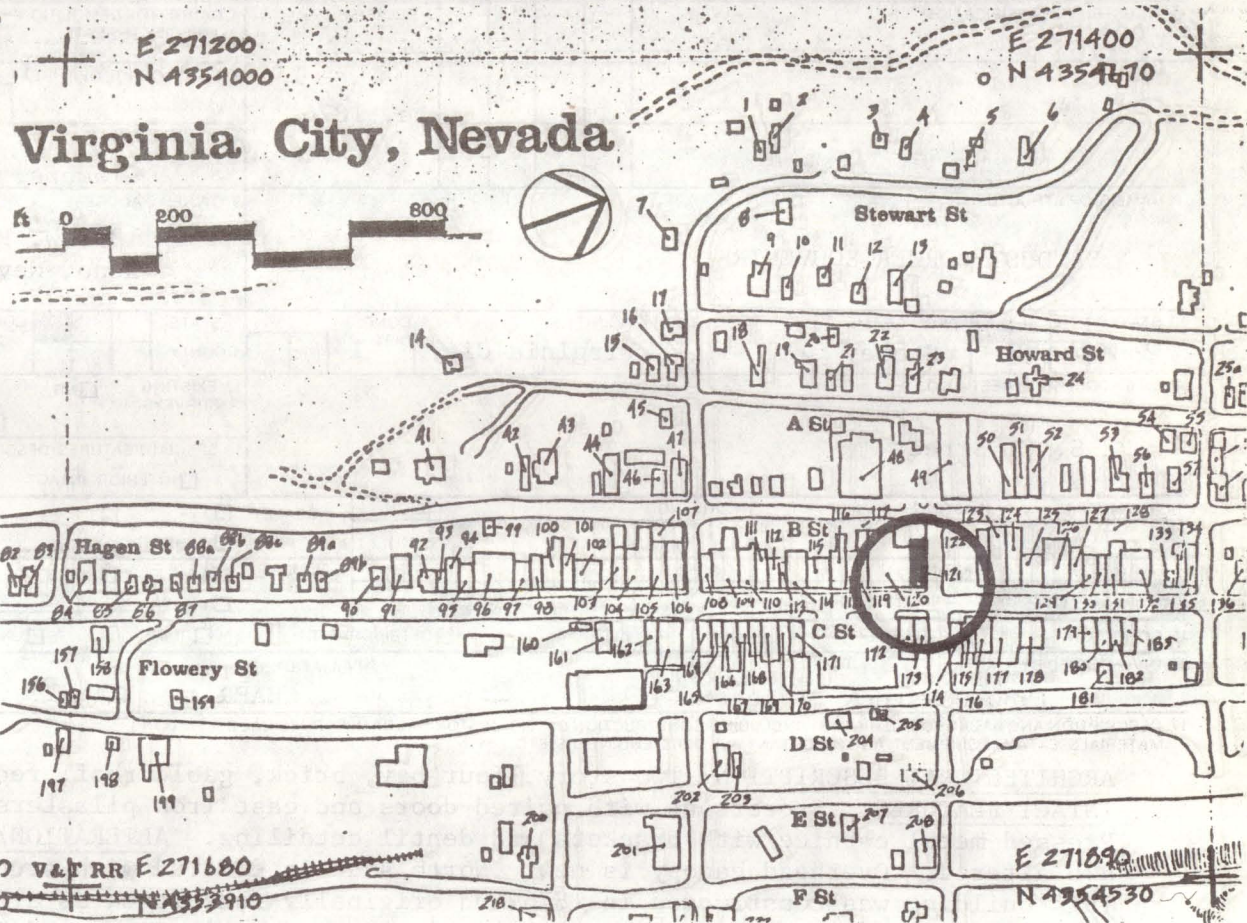
25. PHOTOS AND SKETCH MAP OF LOCATION

**INTACT FEATURES:** Storefront with paired doors and cast iron pilasters, upper story has segmental arched windows. Pressed metal cornice with brackets and dentil detailing. **ALTERATION/MISSING FEATURES:** Storefront doors and windows are altered. Overhead canopy is new. North side is covered with stucco.

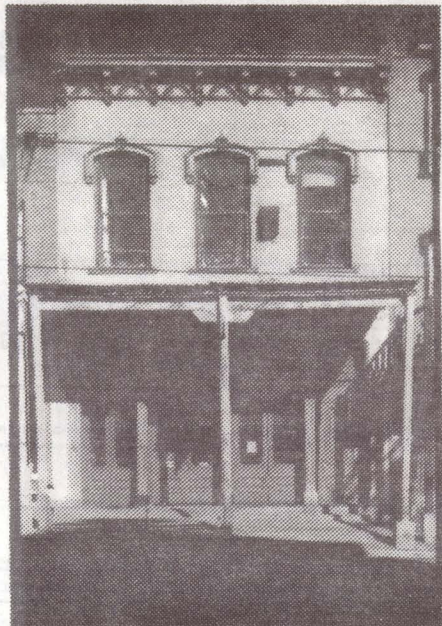
ALTERED/MISSING FEATURES: South Windows replaced with metal frame awning windows. Lower level windows broken and boarded.

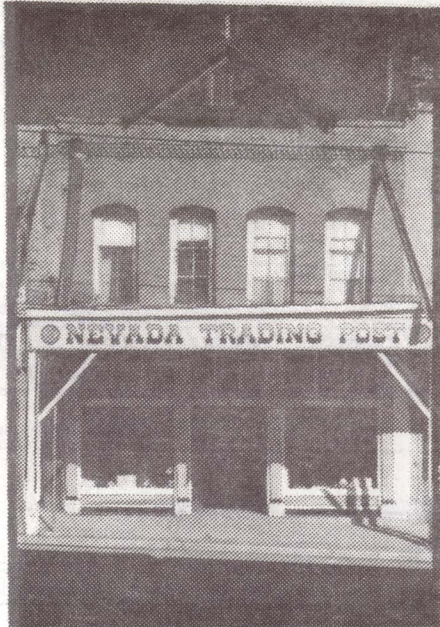
**ARCHITECTURAL DESCRIPTION:** Two-story, four bay storefront, three bays on upper story, brick, hip roof behind front, rectangular in plan, commercial building. **INTACT:** Storefront has paired doors with segmental framed transoms, cast-iron pilasters have Corinthian capitals with egg and dart detailing. Upper story windows have pressed metal segmented hood frames. Cornice has brackets with semi-circular reliefs. **ALTERATIONS/MISSING:** Upper story windows - single pane; cornice is deteriorating on north corner.

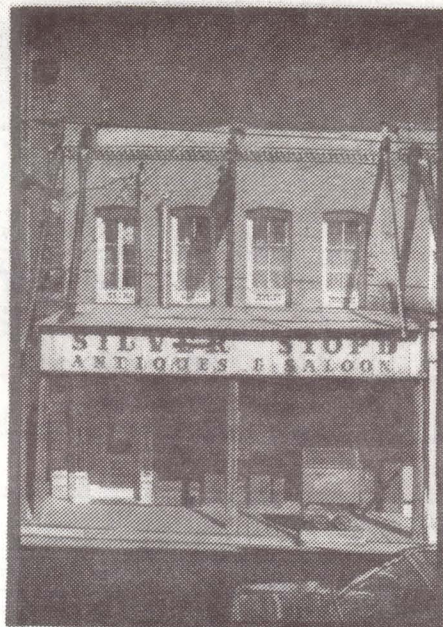
ARCHITECTURAL DESCRIPTION: Two and one-half story, four bay, brick, gable roof, rectangular in plan commercial building. INTACT FEATURES: Storefront with cast iron pilasters. Upper story has segmental arched windows. Cornice has corbeling with dentil detailing. ALTERATIONS/MISSING FEATURES: Porch attached, cornice line is deteriorating, upper portion missing.

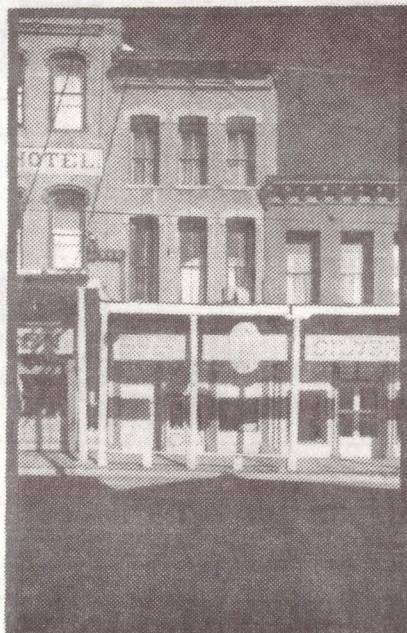
ARCHITECTURAL DESCRIPTION: Two-story, four bays, horizontal wood siding, corrugated metal gable roof behind false front, rectangular in plan, commercial building. INTACT FEATURES: Storefront has wood pilasters. Upper story windows with segmental wood frame and projecting keystone detail. Cornice has large scrolled brackets alternating with rectangular relief panels. ALTERATIONS/MISSING FEATURES: Storefront has altered doors and windows. Cornice is deteriorating.

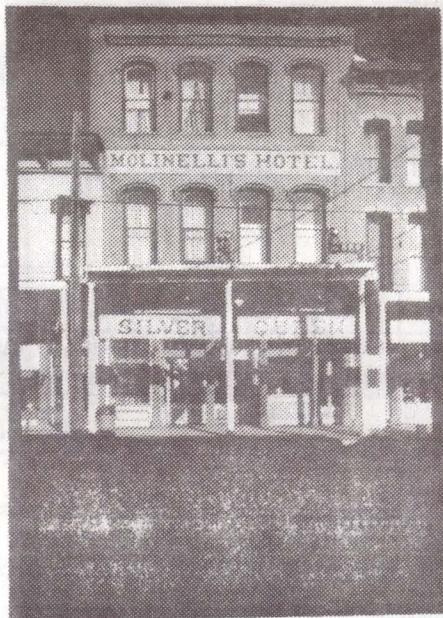
INTACT FEATURES: Storefront has cast iron pilasters. Pressed metal cornice has small brackets with dentil detailing in between. ALTERATION/MISSING FEATURES: Storefront has new wood in-fill construction. Transoms

have been covered over; pressed metal cornice is deteriorating and portions missing.

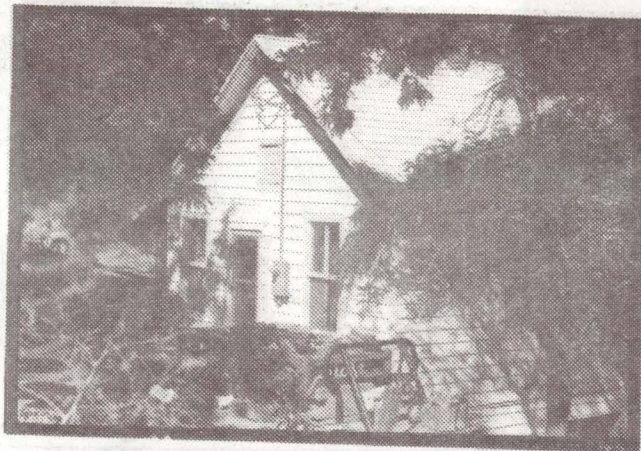
ALTERED/MISSING FEATURES: Shed addition to rear. Portion of Cornice over upper story door missing.

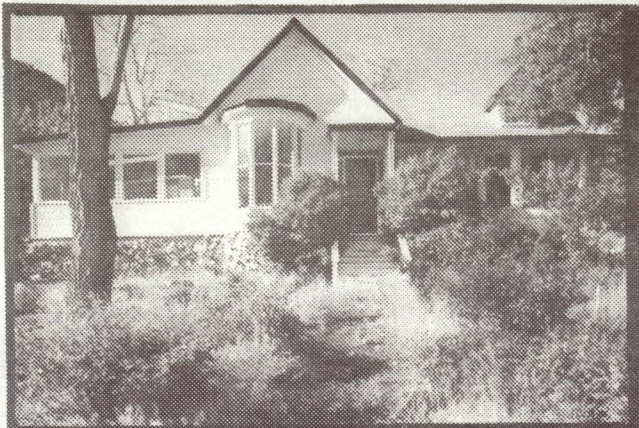
25. PHOTOS AND SKETCH MAP OF LOCATION

**ARCHITECTURAL DESCRIPTION:** One and one-half-story, five bay, wood frame, shiplap-sided, on rubble foundation, gable roof, irregular plan. **INTACT FEATURES:** Front porch W/ attenuated Gothic Revival wood posts which shelters door W/sidelights and transom. **ALTERATIONS:** New additions to right and left of main block; new and altered bay windows on original block. White picket fence on stone retaining wall encloses overgrown landscaped yard; barn and 3 sheds. **HISTORICAL DESCRIPTION:** The original structure was built in 1872-73 by Dawling, a Virginia City assayer. The house was sold in 1890 to Alfred Wills and his wife Annie Greiner, sister of John and William Greiner, after whom the bend was named. The Greiners came west from New York with their mother in 1874 and settled in Gold Hill. The house remained in the Wills family until 1949 when it was sold to Mollie Crocker, and subsequently to V.L. Mc Bride and later to Jack Cross. In 1974 Dorothy Colley and Diane Gordon purchased the house. It was sold to Houston (More)

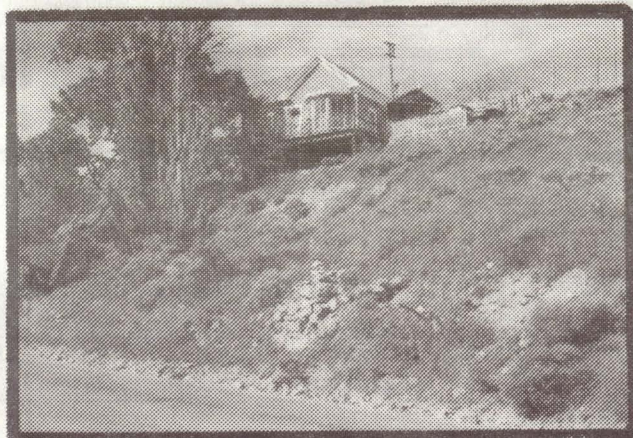
## 25. PHOTOS AND SKETCH MAP OF LOCATION

ARCHITECTURAL DESCRIPTION: Two-story, 3 x 1 bay, wood frame, shiplap sided, gable roof, L-shape residential structure  
INTACT FEATURES: Greek revival detailing of frieze board and returns; door enframant; projecting bay appears  
from Victorian Italianate period. ALTERATIONS: House stands on new, concrete block foundation; moved to this  
steeply sloping site Ca. 1974.

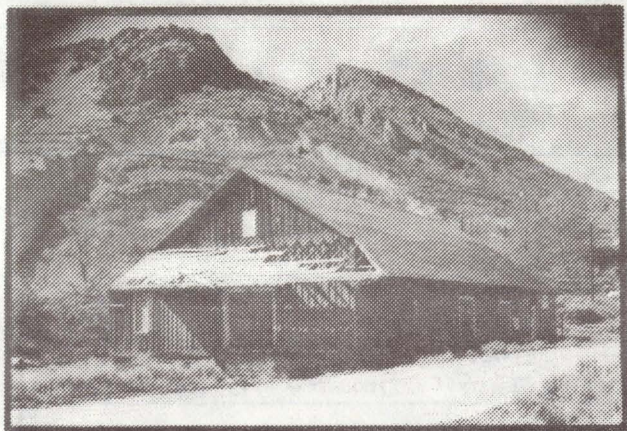
25. PHOTOS AND SKETCH MAP OF LOCATION

ARCHITECTURAL DESCRIPTION: One-story front, one-story back, six bay front, three bay side, six bay back, wood piling foundation, wood frame with (lap siding; board and batten), gable roof of wood shakes, rectangular depot.

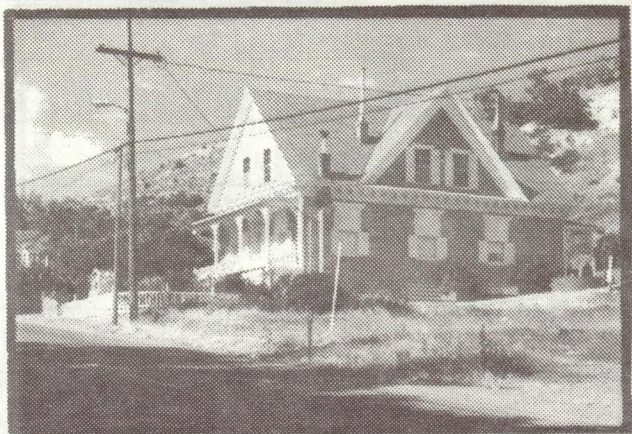
25. PHOTOS AND SKETCH MAP OF LOCATION

**ARCHITECTURAL DESCRIPTION:** One- and one-half story front and back, 3 bays front, side and back. Foundation material undetermined. Wood frame, aluminum siding, gable roof with asphalt shingle, rectangular building plan. End porches, front and rear, with square posts, capitals and sawn brackets. Balustrade rail on porch and entry stair. Bracketed eave cornice, bracketed lintel conics, paneled vestibule with paired 4-panel doors. 4-panel entry door with leaded glass transom and 3-light side lights. Sash windows (6 over 6 pane) with shutters.
