HAER INVENTORY

Historic American Engineering Record
Department of the Interior, Washington, D.C.

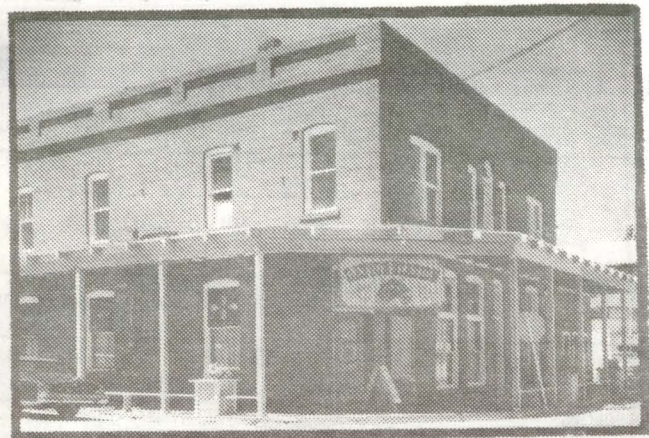
25. PHOTOS AND SKETCH MAP OF LOCATION

15. CONDITION 70 ☐ EXCELLENT 71 ☒ GOOD 72 ☐ FAIR 73 ☐ DETERIORATED74 ☐ RUINS75 ☐ UNEXPOSED76 ☒ ALTERED82 ☐ DESTROYED85 ☐ DEMOLISHED

INTACT FEATURES: 45 degree corner entry with iron column supporting 2nd story overhand. Low arch window and door openings. Double hung sash windows (single, and 2 over 2 Pane). Single light transoms over first floor windows. Two sets of paired glass panel doors with 2-light transoms. Two single glass panel doors with single light transoms. Arched leaded glass transom over second story door. ALTERED FEATURES: Wood sidewalk canopy replaced. One story addition to North side.

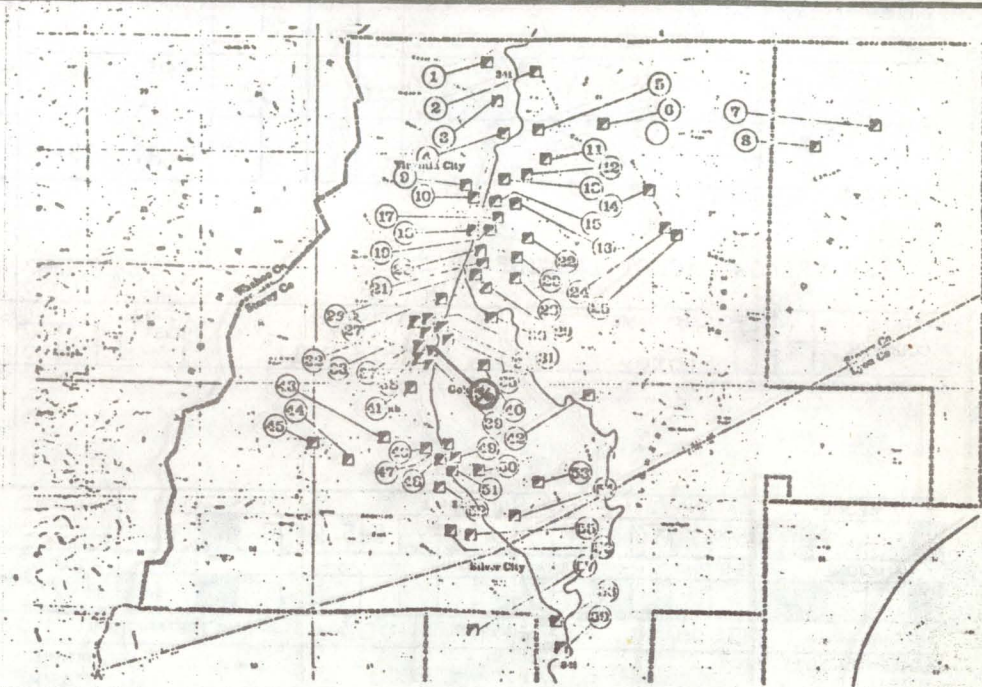
912

15. CONDITION 70 <input type="checkbox"/> EXCELLENT 71 <input type="checkbox"/> GOOD 72 <input type="checkbox"/> FAIR 73 <input checked="" type="checkbox"/> DETERIORATED 74 <input type="checkbox"/> RUINS 75 <input type="checkbox"/> UNEXPOSED 76 <input type="checkbox"/> ALTERED 82 <input type="checkbox"/> DESTROYED 85 <input type="checkbox"/> DEMOLISHED		16. INVENTORIED BY 1980 Comstock Project

17. DESCRIPTION AND BACKGROUND HISTORY, INCLUDING CONSTRUCTION DATE(S), HISTORICAL DATE(S), PHYSICAL DIMENSIONS, MATERIALS, EXTANT EQUIPMENT, AND IMPORTANT BUILDERS, ENGINEERS, ETC. ARCHITECTURAL DESCRIPTION: Two-story, seven bay, brick, twin gable roof, rectangular plan, commercial building. INTACT FEATURES: Storefront-fluted iron pilasters (marked, Gold Hill Foundry), infill construction of paneled bulkheads, double doors, store windows with transoms; second story windows headed by segmental arched metal hood molds, pressed metal cornice at top with faded painted sign on the brick below. ALTERED/MISSING FEATURES: There may have been a porch over the storefront. In 1878 this commercial block was occupied by the Roos Brother's Clothing store. By 1890 the building was divided with the south half a saloon and the north half remaining a dry goods store. The south portion occupied by a saloon was known as the Palace Saloon in 1909. By 1930 the building was listed as vacant in both the North and south portions.		18. ORIGINAL USE PRESENT USE Gift shop; Photo Gallery ADAPTIVE USE

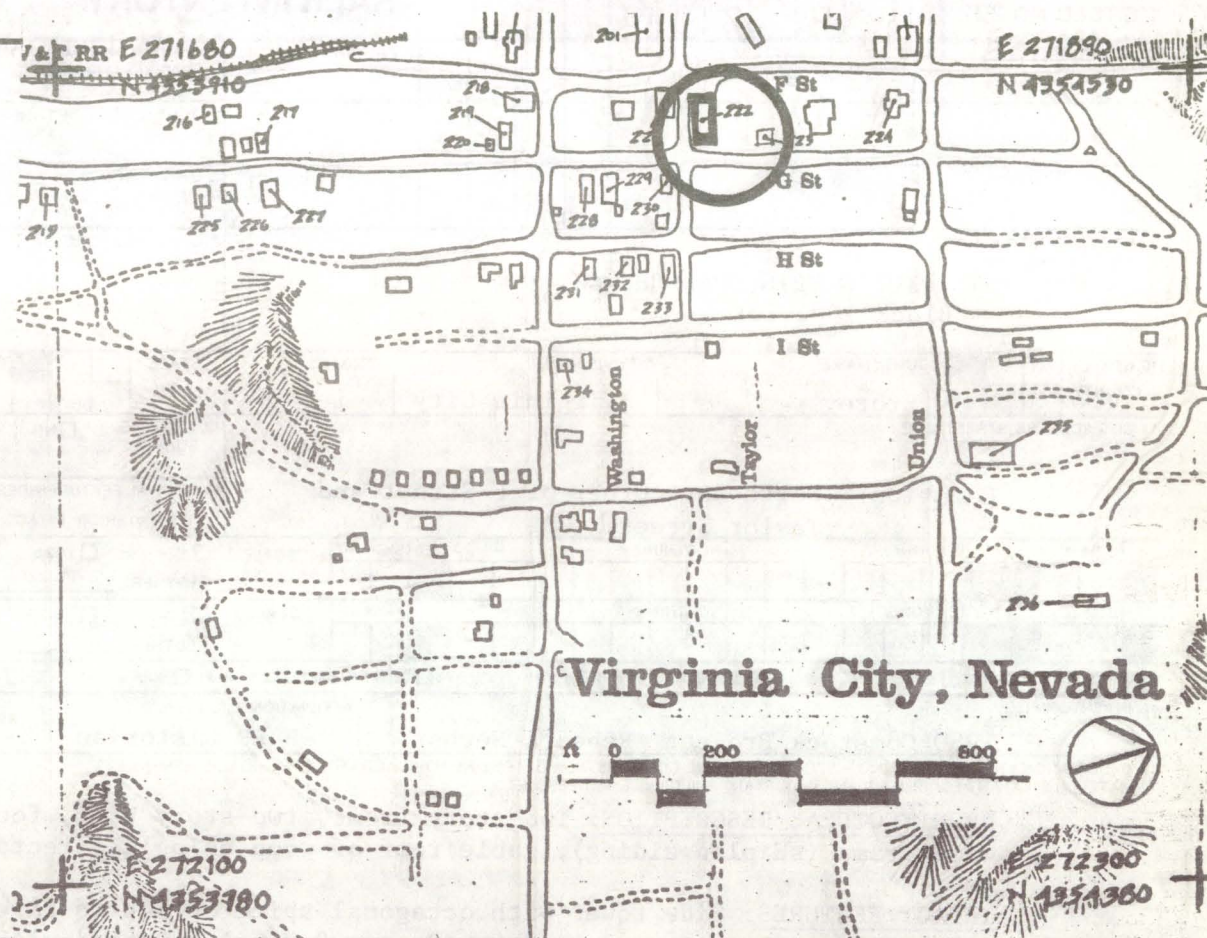
25. PHOTOS AND SKETCH MAP OF LOCATION

was rebuilt on this site during the following year. The later church was 10 ft. longer and 5 ft. wider than the original building and entirely constructed of native pine with its arched beams and walls held together with wooden pegs. The original furnishings and exterior decoration remain almost completely intact.

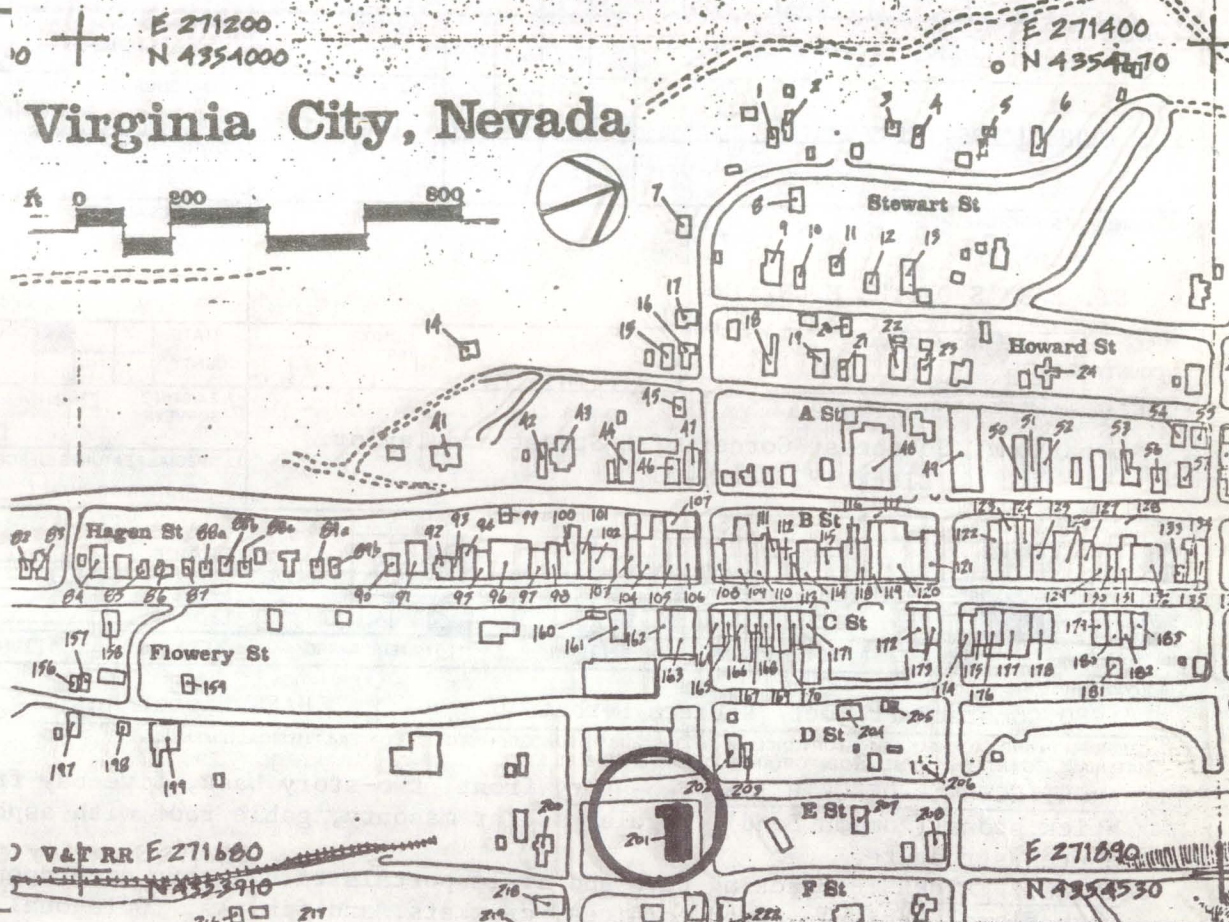
25. PHOTOS AND SKETCH MAP OF LOCATION

by the Catholic congregation. The former churches were all destroyed, the third being ravaged or dynamited during the fire of October 1875. A large brick structure was thereafter erected on this site which may have incorporated portions of the walls of the former brick structure. The new church was dedicated in Aug. 1877. The Catholic congregation numbered between 3,000 and 5,000 members during the boom period of the 1870's. Most of the church ornamentation and interior features such as the rosewood balconies and stained glass windows have been removed from the building. The church remains open for services.

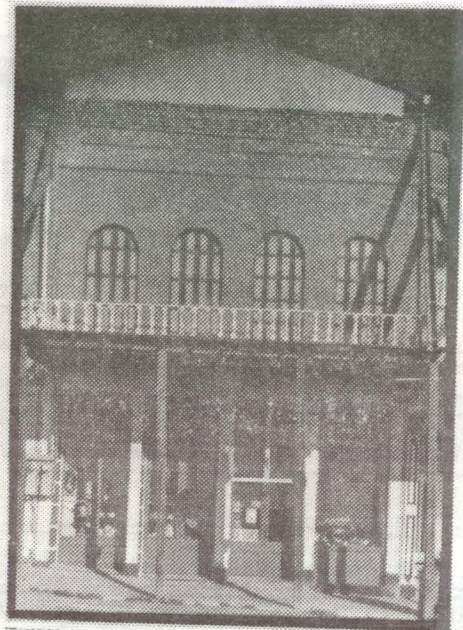
INTACT FEATURES: Storefront—large rectangular windows with transoms above. Cast fe pilasters - pacific co-operation Foundry. Paired doors with cast fe shutters uppers hung. Romanesque arches with windows recessed and cast ironshutters. Horizontal relief across upper story with cornice displaying corbelling and dentils.

ALTERED/MISSING FEATURES: storefront new wood construction. Porch attached with deck. Roof forming 1/2 story projects above cornice line. New rear addition. Cornice brickwork is deteriorating.

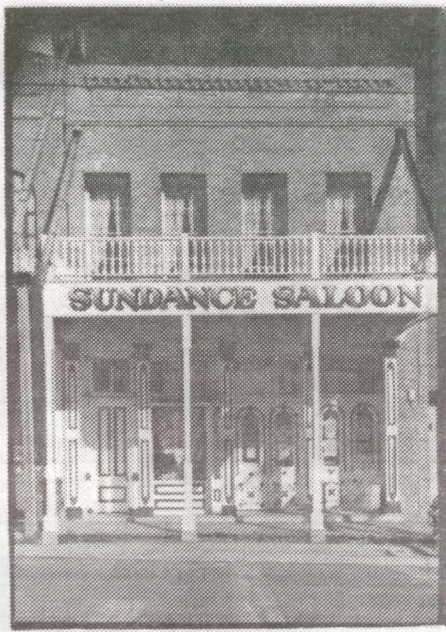
ALTERED/MISSING FEATURES: Storefront: Porch (wood construction) rear addition is new. Cornice and brick work detail is deteriorating. HISTORICAL DESCRIPTION: The building was constructed around 1870 and by 1978 was partially occupied by the Grotto Exchange and Rotisserie, Monaco and Bordini Proprietors. The building continued as 1/2 saloon and 1/2 cigar/Togacco shop through 1907. Professional office space was provided on the second floor. By 1980 the building is listed as vacant.

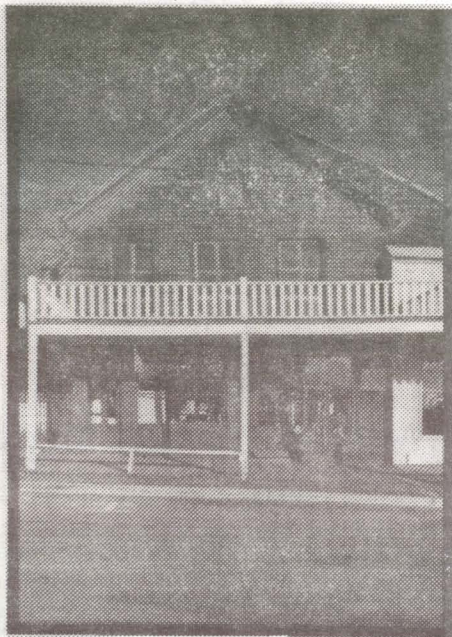
ARCHITECTURAL DESCRIPTION: One-story, two bay, brick, gable roof of tar paper, rectangular commercial structure.
INTACT FEATURES: Storefront has cast iron pilasters paired doors with pacific co-operative Gold Hill.
ALTERED/MISSING FEATURES: Storefront - wood infill construction overhead canopy. Roof line deteriorating.
One wood addition.
HISTORICAL DESCRIPTION: Commercially the building was occupied by George Lammor's Variety Store and a Millinary shop during the 19th century. In the early 20th century a dry goods store was located here, and it was later listed simply as storage.

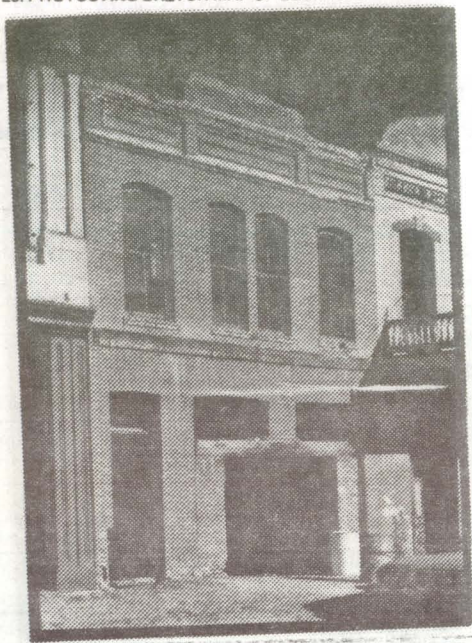
ARCHITECTURAL DESCRIPTION: Two story front, one-story back, three bay front brick (common Bond), rectangular structure with no roof.INTACT FEATURES: Facade wall is all that remains. Iron headers with soldier courses over openings. Sash window frames (2 over 2 Pane). brick frieze and cornice.ALTERED/MISSING FEATURES: Two bays joined by extensions to brick wall and timber lintel.

Rear wall, floors, roof, windows and doors missing.

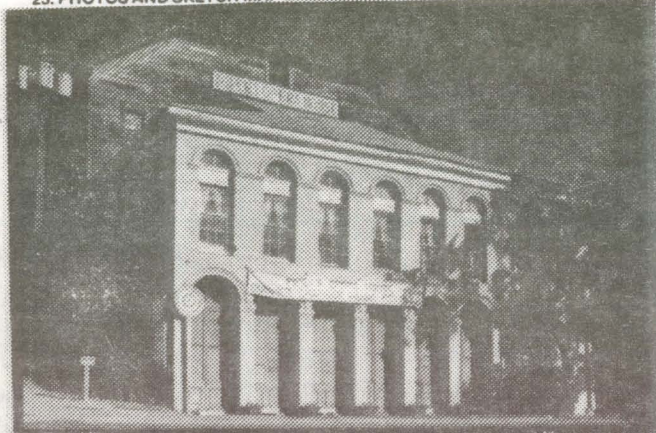
INTACT FEATURES: Brick arcade facade with circular arches. Iron pilasters on Northern-Most opening. Seven sets of paired entry doors with 2-light transoms. Double hung sash windows (6 over 6 Pane). 2-light circular arch transoms over facade windows. Two sets of paired casement windows (3-Pane) with bracketed cornice lintels. ALTERED/MISSING

FEATURES: Two sets of paired steel fire exit doors added to North and South sides. Facade Balcony missing. Wood sill and applied arches missing from South Windows. Glazing missing from entry doors, transoms and several windows.

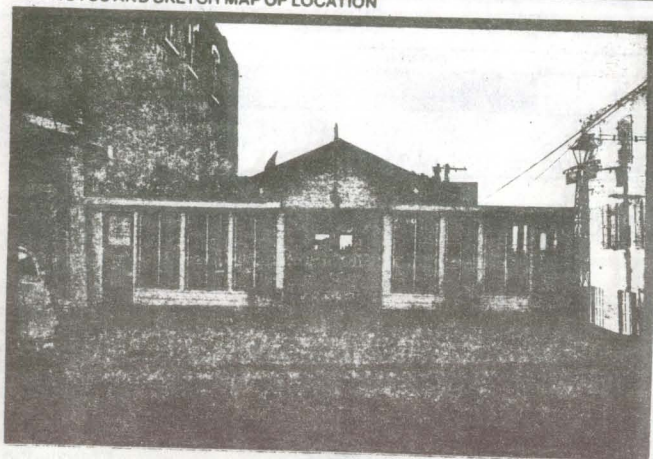
ARCHITECTURAL DESCRIPTION: One-story, wood frame, gable roofed rectangular plan commercial building of recent construction on historic brick foundation. INTACT FEATURES: Foundation has brick walls with intervening wood posts. ALTERED/MISSING FEATURES: Recent construction has no historic character and is of incompatible design. REAR ELEVATION: Brick lower story; altered upper story.

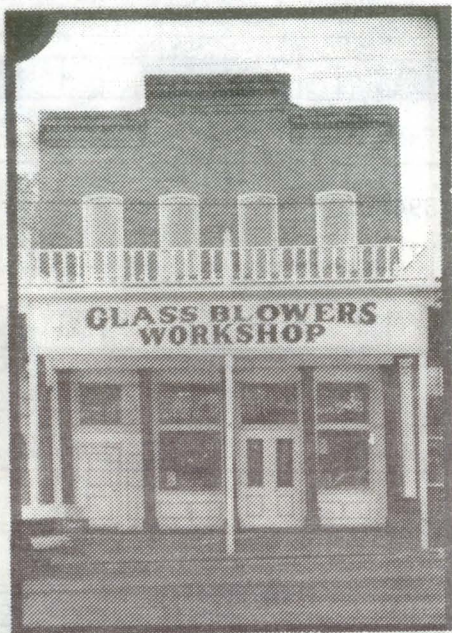
25. PHOTOS AND SKETCH MAP OF LOCATION

ARCHITECTURAL DESCRIPTION: Two-story, three bay, brick, gable roof behind false front, rectangular plan, commercial building. INTACT FEATURES: Iron pilasters, top cornice of highly detailed pressed metal with center swam's neck pediment with date "1869". ALTERED/MISSING FEATURES: New deck porch of highly detailed design, new brick facade of inappropriate materials and design, fenestration altered. REAR ELEVATION: Altered, New Addition. A fire occurred at this address ca. 1905 which left the lot vacant until the present newly constructed building was erect

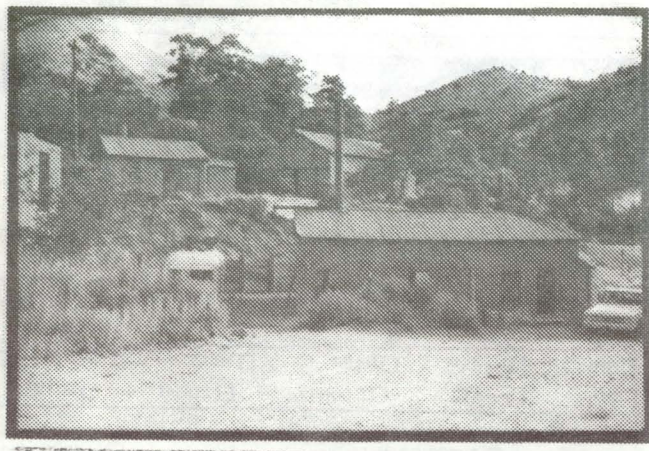
25. PHOTOS AND SKETCH MAP OF LOCATION

ALTERED/MISSING FEATURES: Corrugated steel sheathing and steel overhead door added to East wall. Corrugated steel on wood frame walls constructed inside masonry walls. Shed addition to rear. Double hung sash windows missing.
