REPORT ON
CHARLES PROPERTY
JEFFERSON CANON, NYE COUNTY,
NEVADA.

EXAMINED FEBRUARY 16th, 1920.

By A. F. Carper.

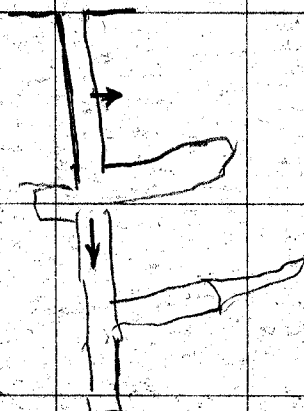
MINE

736

3.1 FT ACROSS FACE SMALL STONE
WEST SHAFT. 100 FT. LEVEL\$572

SHAFT N 35° E V.A. = 28° ±

FOLLOWS VEIN DIPPING N.W.
APPROX 25°.

737

1.6' FT ACROSS TALE & MIN. GOUR
NEW VEIN. NEAR BOTTOM WKGS.\$9950

738

2 FT. ACROSS N. SIDE SHAFT
LENSE 20 FT LONG
WILLIAMS SHAFT\$3878
