Elko District, continued.

Lynn District, Eureka County

Lynn District was visited on June 3, 1932. Placer mining is being done on both sides of the mountain, and the Big Six mine and mill are being operated on a small scale.

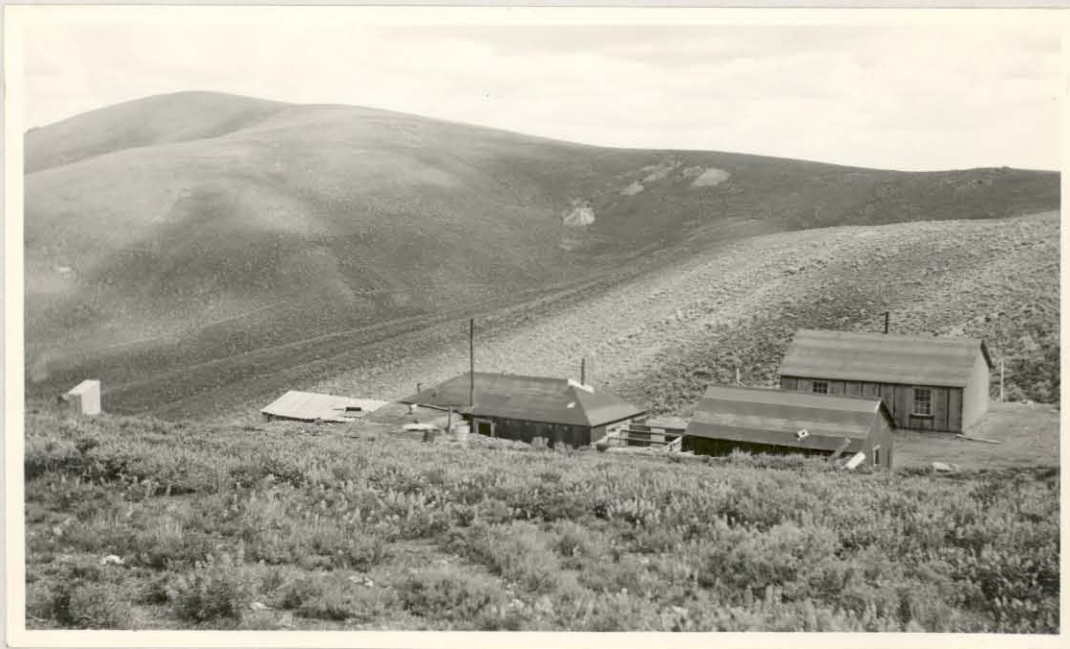
Fig. 2. Looking S over 6 Company mine buildings, Lynn District, Nev. High rolling, well rounded land, covered with sage brush.
