(249)
Item 20

Location Number: NY 006

Location: San Antonio Mine
Coordinates: 38°20' / 117°15' T6N R42E
Elevation: 6800'
Map Sources: USGS San Antonio Ranch; Erickson County Map
References: Paher; Site Investigation 8/9/77
Photographs: PlusX-JMC#2: 14-15
Status: Potential National Register Site

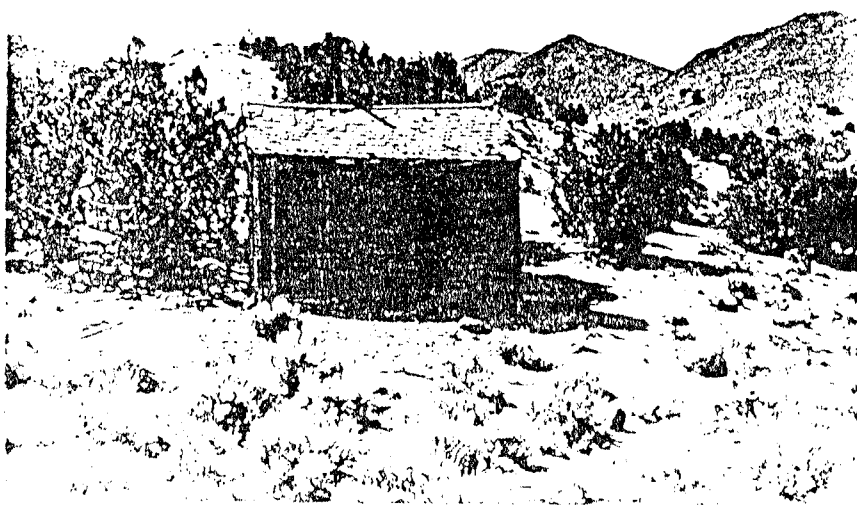
The westernmost canyon has a wood-frame structure associated with rock dugouts. The 14' x 8' x 10 foot high cabin has its long axis oriented east-west. Rectangular metal cans have been cut, opened, flattened, and then applied as an exterior wall covering. The shingle-

covered medium-pitched roof has a sagging ridgepole. A bent 6-inch stovepipe rises 4 feet above the roof. The north elevation has a door located near the northeast corner that occupies 20% of the elevation. The east and west elevations hold one window each that made up 20% of those elevations. The cabin has mud sills which in turn are resting on rocks that function as piers. The floor is 1" x 12" wood that is covered with linoleum.
