(254)  
Item 44

Location Number: NY 005

Location: Black Mountain Ruins  
Coordinates: 38°10' / 117°13' R42E T3N  
Elevation: 6800'  
Map Sources: USGS Tonopah Quadrangle  
References: Site Investigation 8/10/77  
Photographs: PlusX-JMC#3: 27  
Status: Potential National Register Site

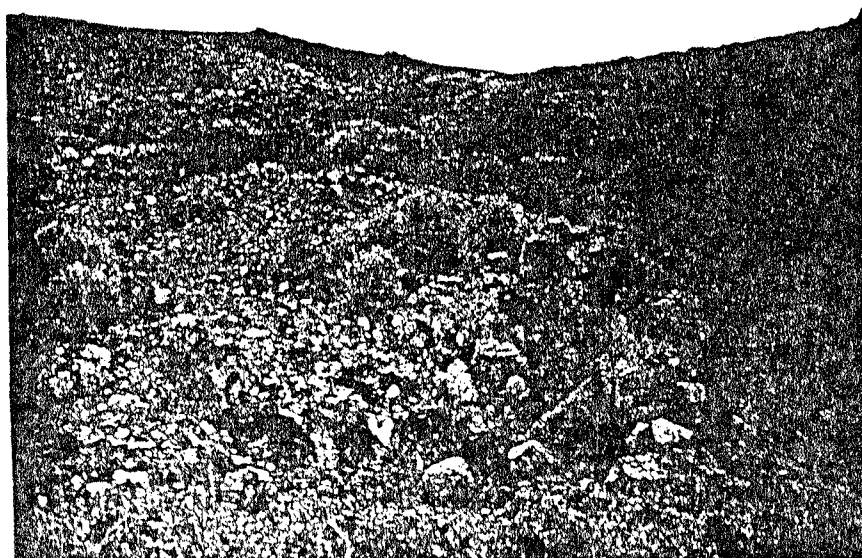
The site of the Black Mountain ruins is in the San Antonio Mountains. The gently sloping terrain is dotted with sagebrush. The ruins consist of some mine diggings, mortared rubble-rock walls that have almost entirely collapsed,

and a considerable amount of debris -- bottles, cans, bedsprings, corrugated metal, pieces of wood. On the southeast exposure of a small mountain near the ruins is a mine. The mortared walls, approximately 3 feet high, once encompassed a 10' x 8' structure. There is also an excavation for a structure that was approximately 7 feet square. On the side of the hill is a low retaining wall.
