July 15, 1966.

Re: Condition of and damages to
White Peaks Mercury Mine, from
recent operations.

Your White Peaks mine, under lease and option to Cinnabar Canyon Mines, Inc., since 1964, was examined On July 10 and 11, 1966, by the writer.

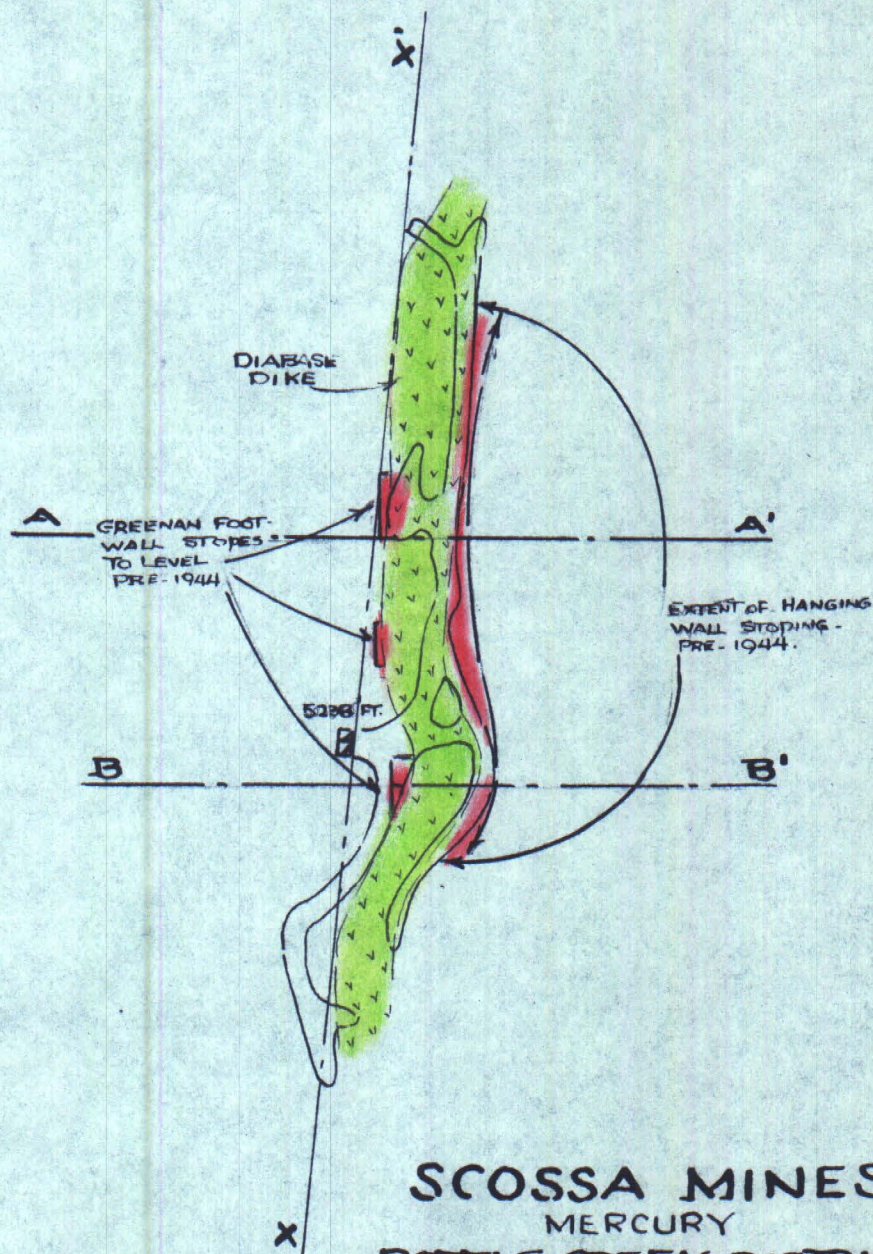
SCOSSA MINES
MERCURY
BOTTLE CREEK DISTRICT
HUMBOLDT CO., NEVADA
WHITE PEAK MINE
62 LEVEL
1" = 50 FT.

Damage #1 represents the condition of the shaft above the 62 level. The area has been weakened, should be carefully checked, lagging and timbering replaced and strengthened, and openings between lagging and the solid filled with 'gob'.

Competent miners should be put to work in the White Peaks shaft to (1) repair the shaft above the 62 level where needed, (2) bridge over the 40 feet of open ground at (b) with solid timbering and a trestle (a temporary expedient since the void should be filled) and (3) with stulls from below supporting a mat of timber and the remainder of the pillar, the pillar, itself, might be saved.
