The Nevada Wonder Pipe-Line

Automatic Devices for Checking Interruptions to Service

By J. A. Burgess

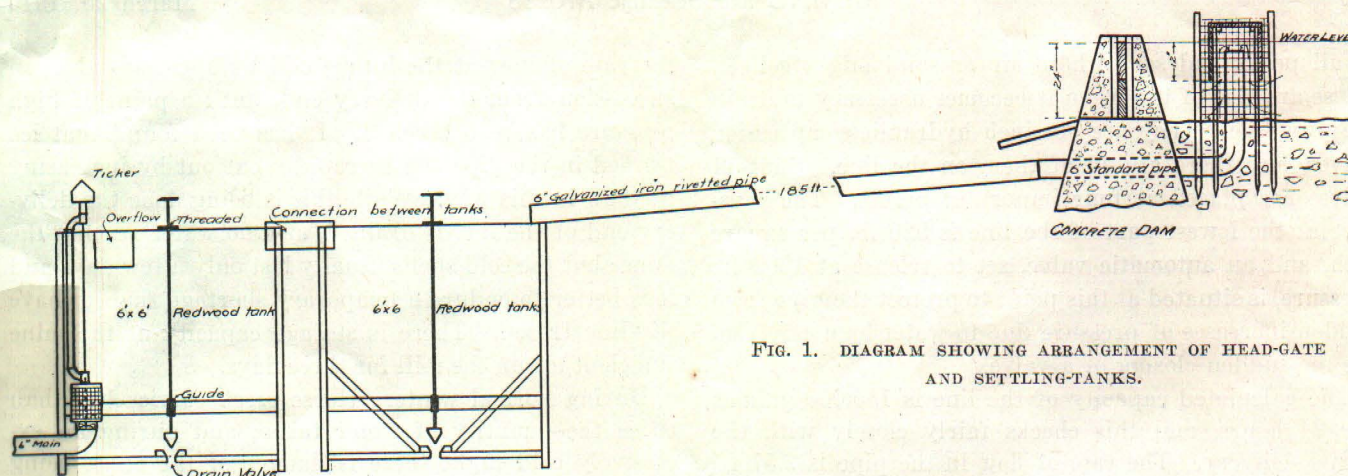
FIG. 1. DIAGRAM SHOWING ARRANGEMENT OF HEAD-GATE AND SETTLING-TANKS.

The arrangement of the head-gate and the mechanical protective devices are as follows: Fig. 1 shows the arrangement of the head-gate and the settling-tanks. The dam backs up water to a depth of two feet. Removable boards, set horizontally in grooves, afford a means of sluicing out gravel accumulated during freshets. The entire bottom of the canyon is formed of loose rock-debris and soil, and the grade is so steep that a storage-dam would be impracticable; and in addition to this the danger of cloud-bursts forms an objection to the erection of expensive headworks. For these reasons no improvements beyond those strictly necessary were made. The intake at the dam is arranged to give a constant water-level, and to take the water from a depth of 12 inches below the surface. By these means a considerable depth of ice on the dam does not interfere with the flow into the pipe, as long as there is running water in the stream. As an additional protection, the dam is boarded over in winter. Ample area of screen, $\frac{1}{4}$ -inch mesh, is shown sur-

rounding the intake. Two small tanks are provided for the purpose of trapping sand. The first has a conical bottom, and both are furnished with discharge plugs operated from above by threaded rods. Both tanks are covered. They are placed at the side of the canyon where only an unusually heavy cloud-burst would damage them. Delivery from the dam to the tanks was originally made through a square wooden flume, but when this became leaky, galvanized sheet-iron pipe was laid inside of it.
