2110 0016

92  
Item 10

Location Number: ES 027

Location: Gold Mountain  
Coordinates: 37°18' / 117°25' T7S R41E S26  
Elevation: 5820'  
Map Sources: USGS Gold Point SW; Clason 1906  
References: Carlson; Paher; Mordy; Angel; Site Investigation 8/31/77  
Photographs: KR64-GK#1: 1-6; PlusX-JMC#1: 16-32  
Status: Potential National Register Site

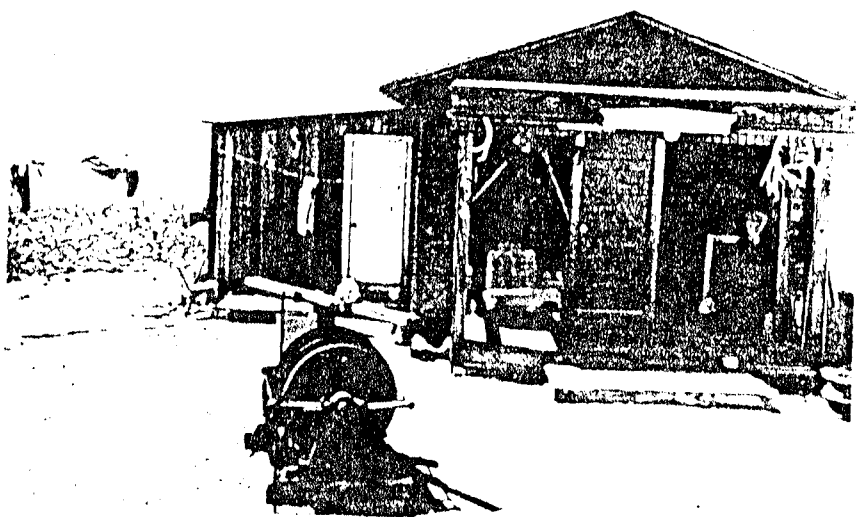
Situated in a slight saddle on the northern slope of Gold Mountain is the mining camp of the same name. It lies west of Sarcobatus Flat and south of Slate Ridge. The camp also goes by the name Stateline, the mine that was discovered in 1864 and initiated the original settlement. Among the sagebrush at the site, there are numerous stone ruins, a few timber shacks, debris, and an operational mine.

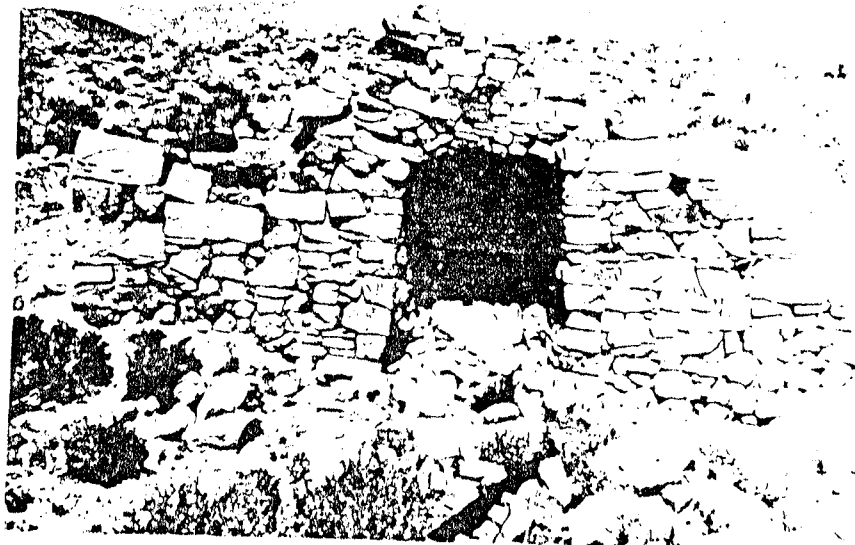
Of the numerous stone ruins, two located near the road at the toe of the southern hill are typical. Each measures about 14' x 12'. The walls are of unmortared rubble rock with mud chinking. These deteriorated walls range in height from 18 to 24 inches, and are 24 to 28 inches thick. West of these is a rock structure that is built into a bank. It stands about 7-1/2 feet high and about 12 feet across the front. The 28-inch-thick walls are of mortared angular stone. Facing south is an arch-type opening,

about 6' x 3', that  
recedes 2-1/2 feet  
into the structure.  
The back wall of  
this interior space  
has a 24" x 18" rec-  
tangular hole, and  
above this hole two  
3-inch-diameter  
pipes protrude. This  
structure was used as  
a furnace.
