Location Number: NY 048

Location: Golden Arrow
Coordinates: 38°00' / 116°36' T2N R48E S28
Elevation: 6000'
Map Sources: USGS Stinking Spring Quadrangle; Erickson County Map; Nevada Map Atlas; Clason 1906
References: Paher; Carlson; Mordy; Personal Communication with Cecil Lang; Site Investigation 6/21/77
Photographs: KR64-CK#11: 2-6; PlusX-JMC#2: 3-9
Status: Potential National Register Site

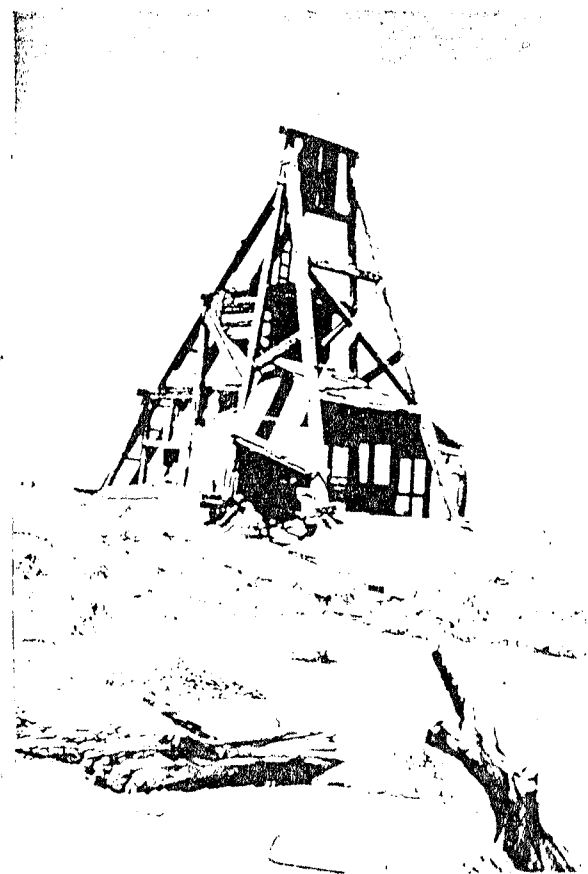
The largest structure at the site is a 25-foot-high headframe constructed of 8" x 10" timbers bolted together. The cross-bracing of this structure is adequate and the general construction is good, although the superstructure is not well supported by its 12" x 12" piers.
