DATE 6-7-68		FREDRIC H. MOLL ARCHITECT 3135 INDUSTRIAL ROAD PHONE: 735-3040 LAS VEGAS, NEVADA 89102	NATIONAL FALLOUT SHELTER UPDATING SURVEY FOR NAVAL FACILITIES ENGINEERING COMMAND CLARK COUNTY CIVIL DEFENSE	41-E BLUE DIAMOND MINE		SHEET	
REVISIONS				NW 1/4 SE 1/4 SEC.32 T21S R59E FACILITY NO. 00200	BLUE DIAMOND, NEVADA STD. LOC. NO. 7411-0017	1	
BY				SPACES 4208	SPACES WITH VENT 4960		OF 1

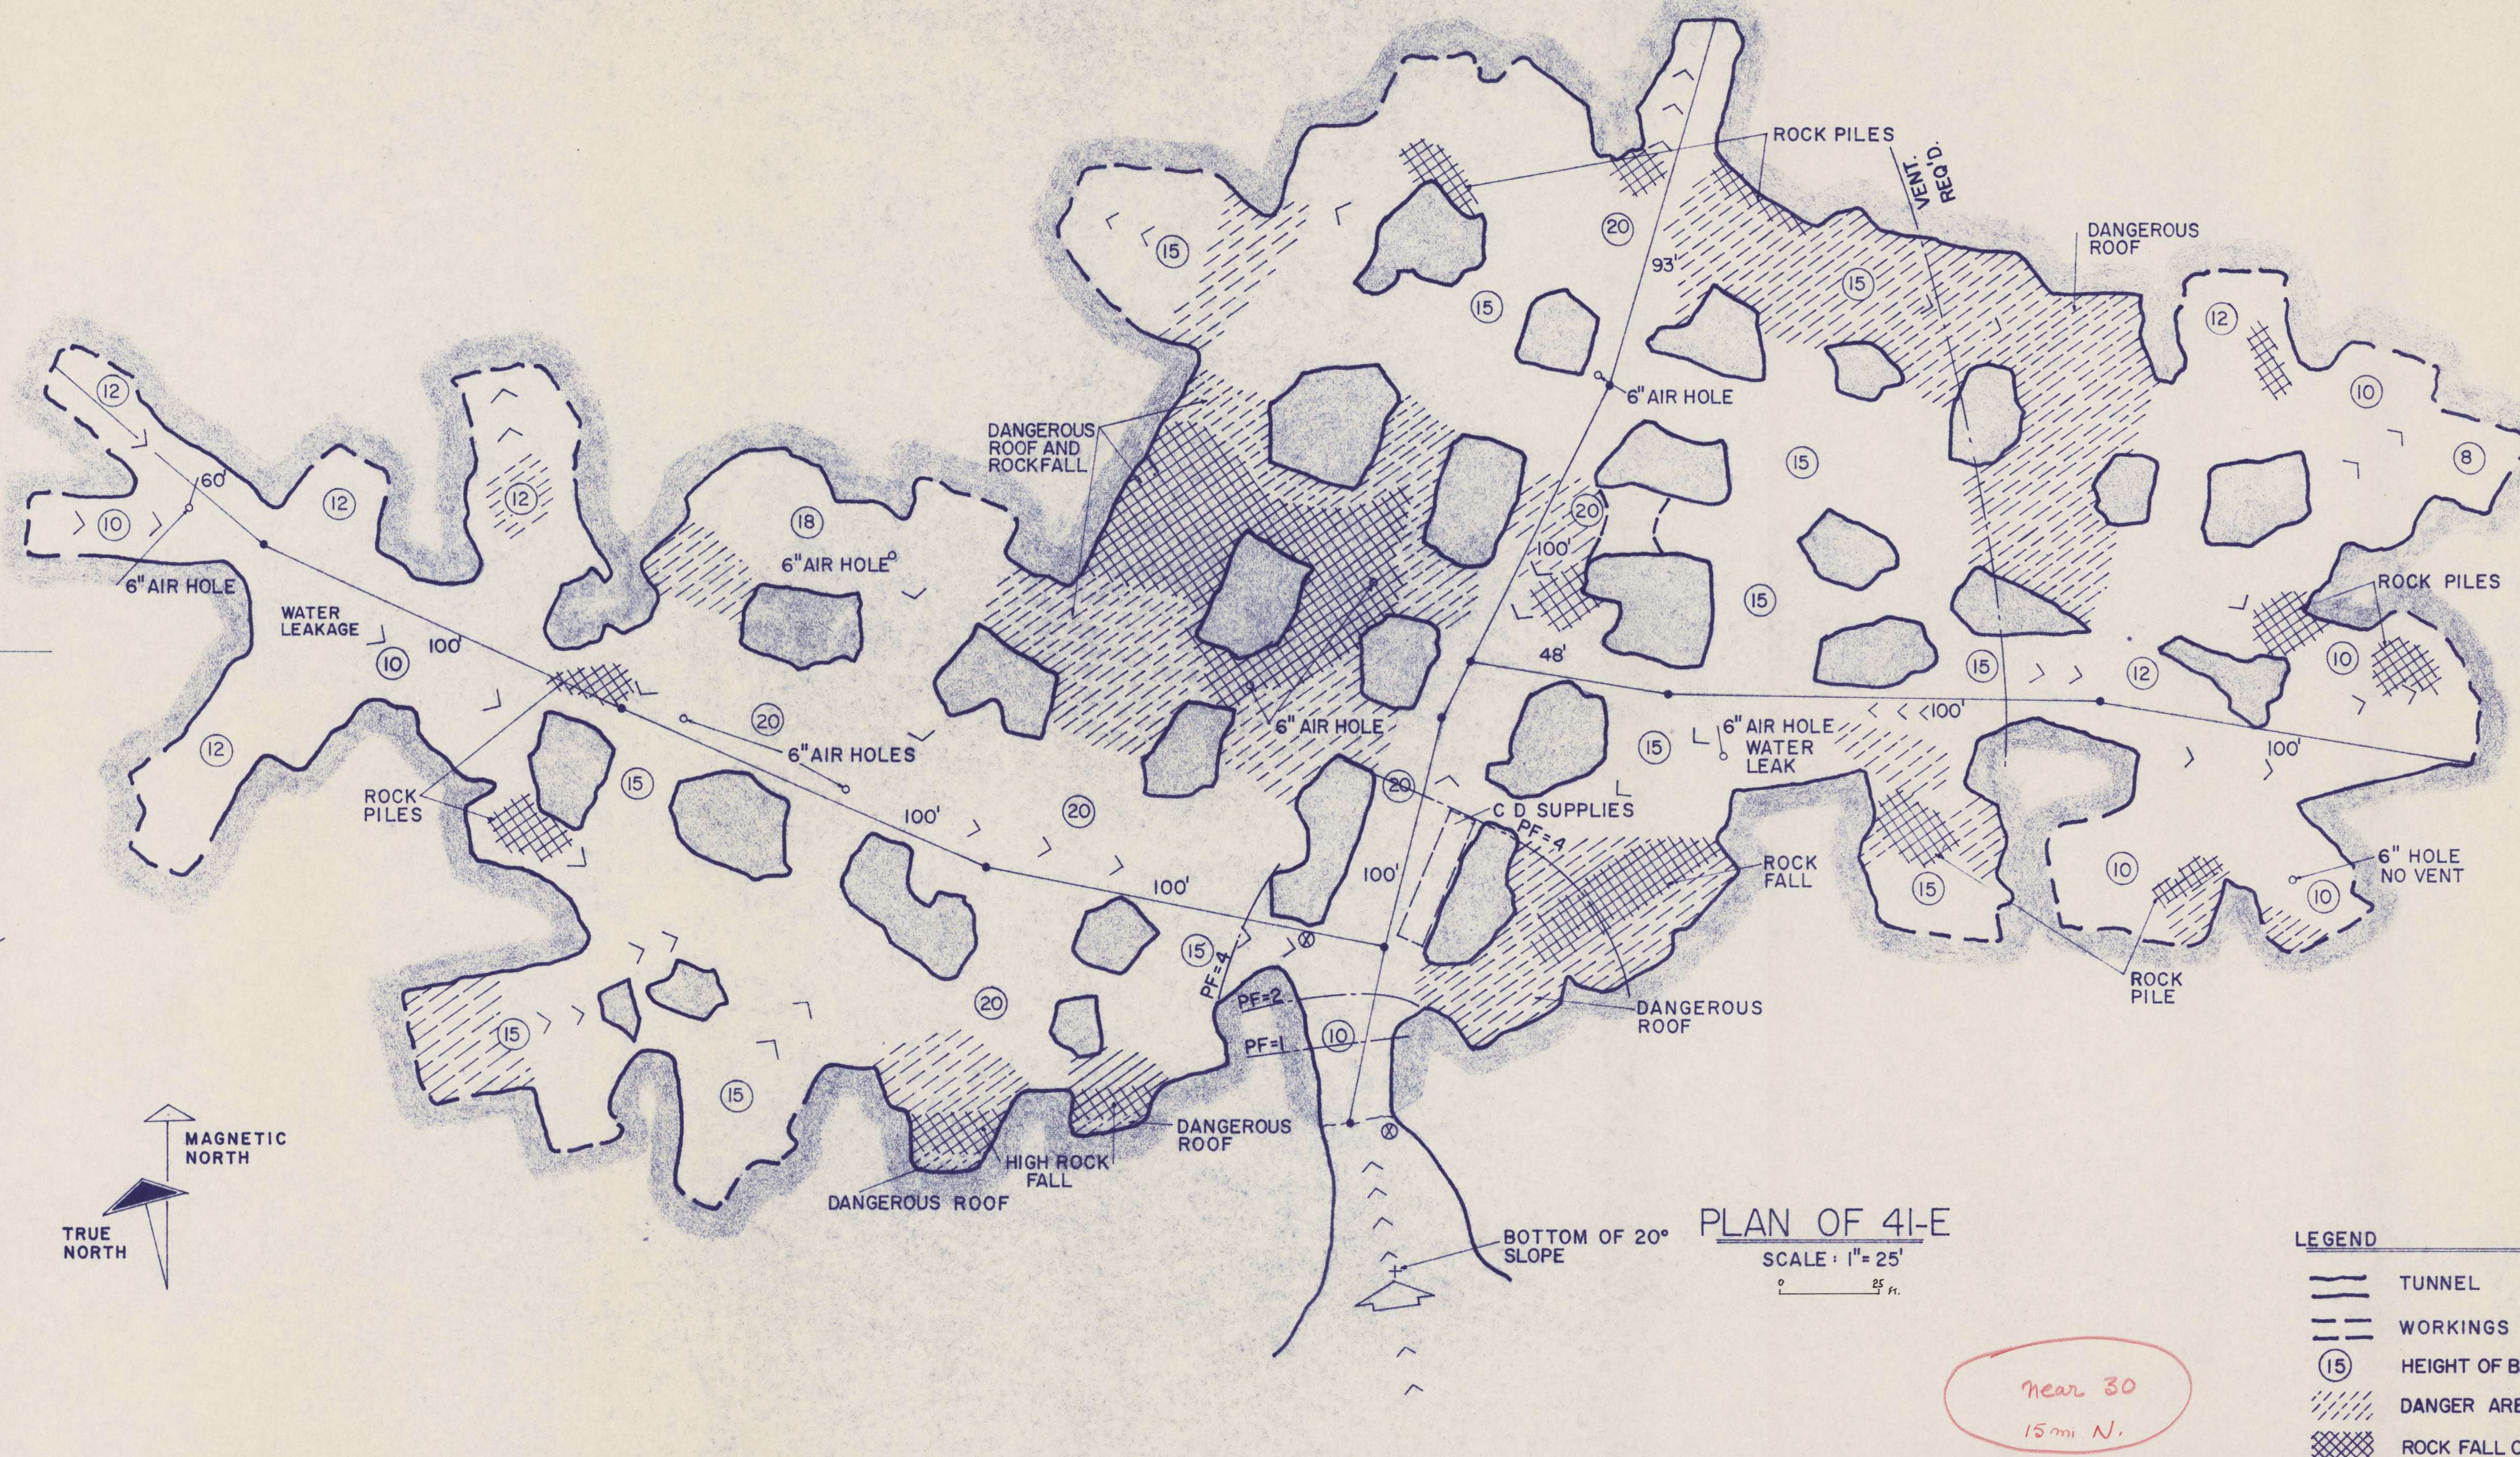
1. WELL MAINTAINED GRAVEL ROAD ON MINING CO. PROPERTY INSIDE GATE.
2. ADEQUATE PARKING FOR CARS JUST ABOVE RAMP DOWN TO THE MINE ENTRY.
3. C.D EQUIPMENT COULD BE DRIVEN INTO MINE AS MAIN ENTRY PORTAL IS 10' HIGH BY 18' WIDE.
4. WALLS ARE STABLE~ ROOF IS DANGEROUS IN A FEW SPOTS. MOST AREAS INDICATED AS ROCK PILES ARE GENERALLY UNREMOVED WORKINGS.
5. 6" HOLES IN ROOF GIVE GOOD VENTILATION BETWEEN THOSE LOCATIONS AND ENTRANCE PORTAL.
6. OUTSIDE TEMPERATURE = 100° F, TEMPERATURE AT 200' DIRECTLY BACK FROM ENTRY = 65° F.
7. RECOMMEND THAT MINE BE INSPECTED BY A MINING ENGINEER.
